The Value of Routine Preventative Measures

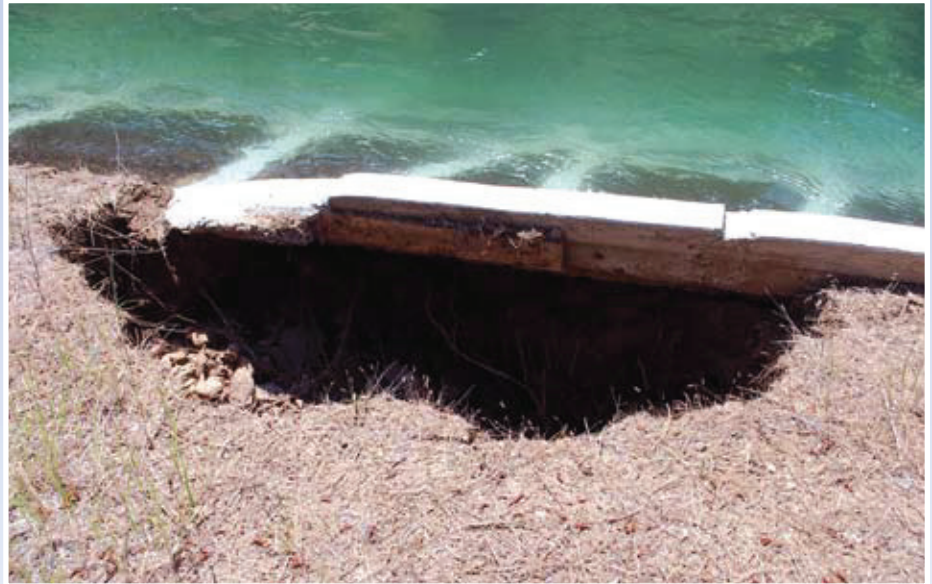
Void in the canal bank and intact lining.

As soon as the South Branch gate closed, the water level rose above the concrete panels lining the canal at a point upstream of the gate and started flowing over the canal bank. While the water did not wash out the adjacent canal bank roadway, it did flow into the rocky fill of the canal embankment. Soil was washed out from between the rocks, allowing the concrete canal lining to settle at least 1 foot into the void. Parts of the canal lining were unsupported while water was flowing at abnormally high levels in the canal.

Led by District Manager Ken Hasbrouck, KRD staff and crew took quick action to assess the situation and create a plan of action. KRD requested that CH2M HILL engineer Dick Haapala visit the damaged area the following morning. He observed the void in the embankment and several concrete lining panels suspended in midair next to the void. Even though the canal lining had moved, it was intact and holding water in the canal.

After assessing the damage, Mr. Haapala determined that the lining was stable as long as it was not disturbed and a proper amount of support could be added behind it. KRD carefully placed a controlled density fill (CDF) consisting of a very low-strength concrete in the void in the canal bank to provide support underneath the lining. CDF is usually composed of sand, a little cement, and additives to make it flow in and around rock voids or pipes. In the end, the lining had settled more than a foot, lower than what it should be to provide a normal amount of freeboard. To raise the canal side back up after the CDF had set, KRD formed and poured a concrete curb on the top edge of the lining.

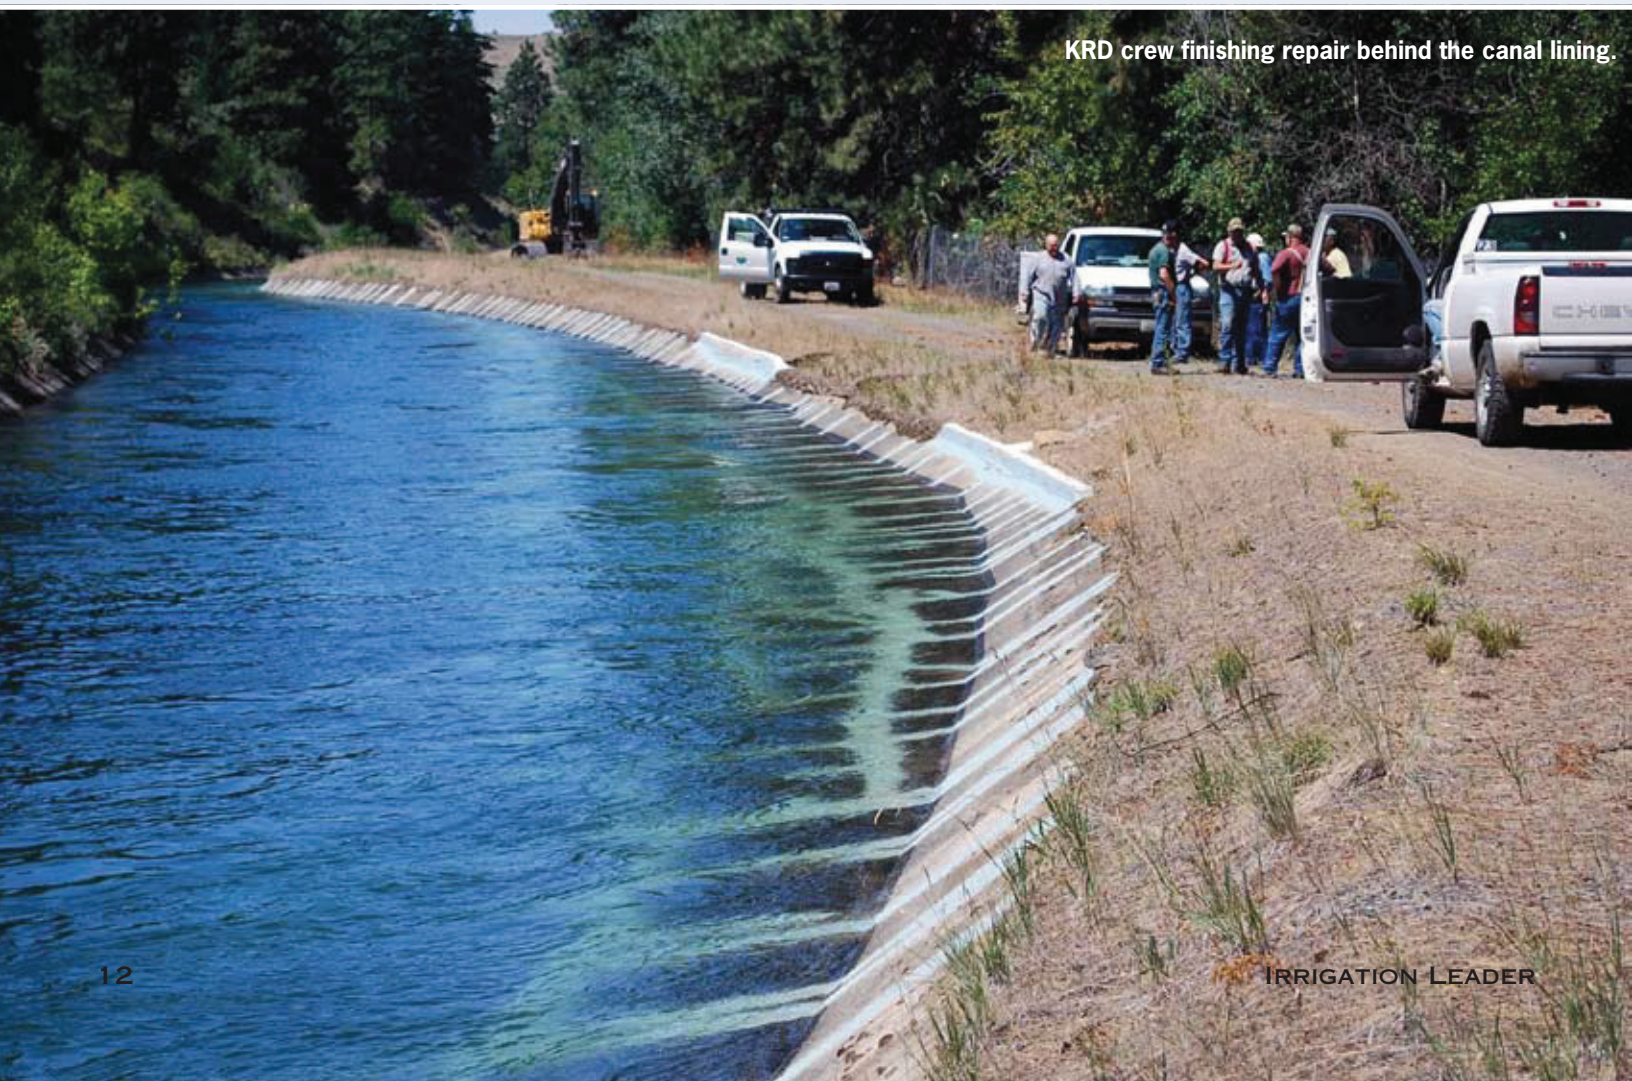
KRD crew finishing repair behind the canal lining.

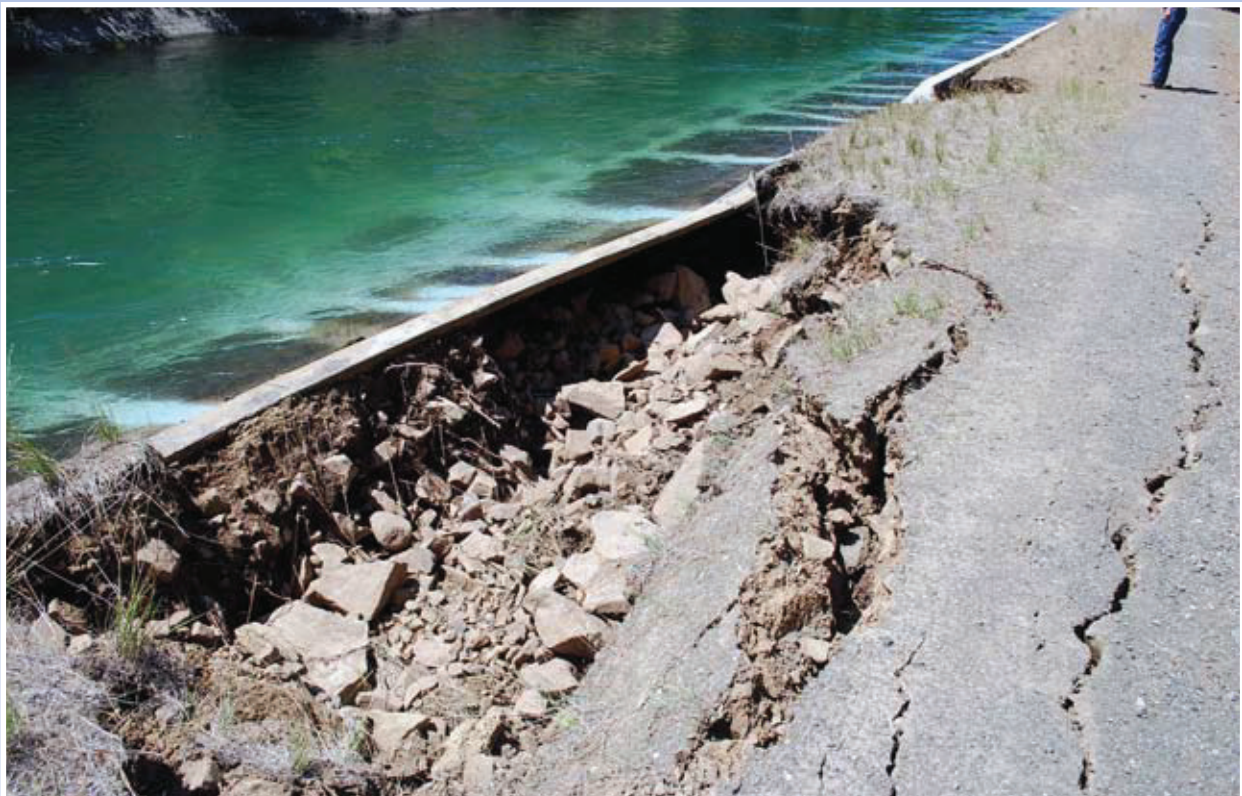
Damage to the canal bank on KRD's Main Canal.

gate that feeds the South Branch Canal. The gate fully closed, putting additional water in the Main Canal, which was already at maximum flow, and causing a significant overflow of the concrete-lined canal.
