## Marine Home Makeover

By Stephanie Marie Chizik

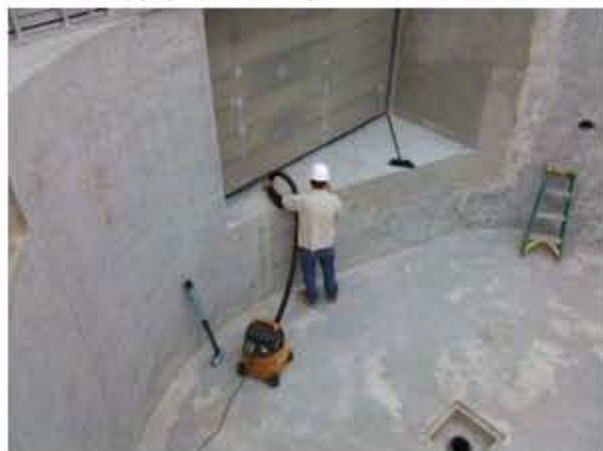
Logistical problems solved, the AP team was ready to work. To prepare the surface, they removed the old coating and disintegrating concrete with a mechanical etching machine equipped with grinding wheels. An abrasive blast brought the surface of the tank down to the desired concrete profile. They allowed it to dry completely before testing the vapor outgassing levels with ASTM D4264 concrete moisture meters. They adhered the square visqueen sheets over the concrete, which helped to ensure that no additional moisture was seeping out of the concrete and, therefore, that the coatings would properly adhere. Although most marine tanks need to be kept full of water, this tank needed anything but that.

With the concrete dry, the team proceeded to fill any of the damaged or uneven areas with polymer modified cement. This evened out the surface and got it ready for the primer. For the best chance of success, the AP team decided to prime in the evenings when the concrete was at its coolest temperatures and, therefore, most likely to absorb the primer. They applied three coats of Polyprime-100 by Specialty Products, Inc. (SPI) to help further discourage moisture migration in the concrete. These extra steps, in addition to taking proper safety precautions—using a human barrier around the spray area, retaining a third-party safety coordinator on site, and wearing Tyvek suits and 3M organic vapor cartridge respirators—kept the AP team afloat.

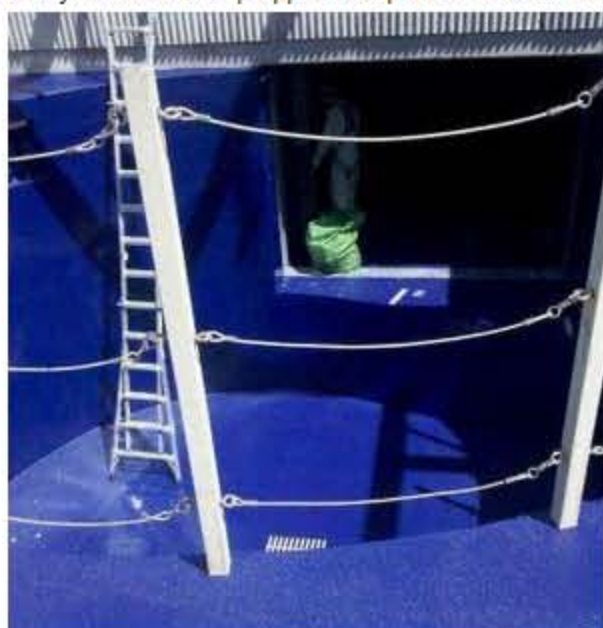
They rolled on each of the three layers of primer over the course of a day and a half while working around the animals' schedules for safety (particularly the nearby sea otters). Finally the tank was prepped and primed. The AP team then used a Gama G20H hydraulic proportioner to spray-

apply SPI's Polysield HT polyurea in an average thickness of 90 mils (2,286 microns). For the majority of the surface, they used a Graco fusion air purge spray gun, but for detail work, they used Pentech Inc.'s mechanical purge Palm Gun. Naturally, the aquarium chose to have the marine tank coated in the color Diego Blue.

After 56 hours, the polyurea was dry. Once the other construction companies finished their tank projects, the animals were brought back into their newly improved home. After one year, the AP team returned to inspect the success of their polyurea coating; they found that the tank was not only standing up to the water pressure but also to the standards of the Monterey Bay Aquarium's marine animals and crew. It was such a success that the AP team has since been asked to return for six additional projects! The next project to come down the chute: sea otters. Otters, puffins, and turtles. Oh my!
