# High-Tech Coatings Help History Raise The Roof

"To live at Marlborough House is a mark of social distinction." Thus read a 1927 Seattle, Washington newspaper ad describing the newly opened, 12-floor apartment building conveniently located in the city's fashionable First Hill district. Built in the Art Deco style by famed Seattle architect Earl W. Morrison, Marlborough House was a brick and reinforced concrete marvel.

Fast-forward 80 years and the social distinction had turned to social stigma. The once beautiful apartment building had fallen on hard times and was in need of revitalization. "The building was in desperate need of a new roof," says Rob Crispin, vice president of Vector Construction, Inc., the coatings contractor hired for the project. "Because the owners wanted to rent the vacant building out as soon as possible, we would be working a tight schedule, around multiple other trades, regardless of the weather conditions."

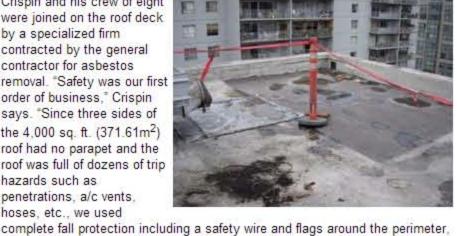
Crispin and his crew of eight were joined on the roof deck by a specialized firm contracted by the general contractor for asbestos removal. "Safety was our first order of business,\* Crispin says. "Since three sides of the 4,000 sq. ft. (371.61m<sup>2</sup>) roof had no parapet and the roof was full of dozens of trip hazards such as penetrations, a/c vents, hoses, etc., we used

full body harnesses and lanyards with retractable lines, and a dedicated supervisor watching the crew at all times. We also held daily safety meetings and one of the things that we discussed was the hazard of dropping things off of the roof-this included tools, products, and most importantly ourselves. Nothing could drop off of the roof. Especially in Seattle's wind, we had to be on constant guard." While the specialized firm

removed the asbestoscontaining old tar roof, the Vector crew followed at a safe distance-wearing dual cartridge full face mask respirators, Tyvek suits, gloves, and goggles-using hand tools to clean and prep the concrete roof.

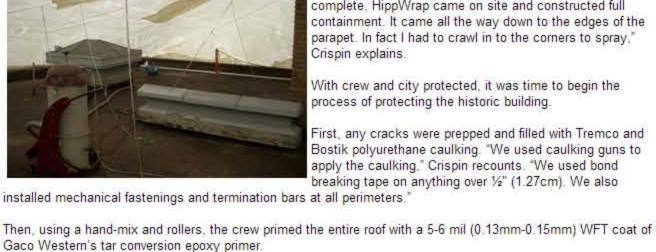
a new roof on the historic building as quickly as possible. But surrounding buildings made overspray a major concern. Because of high winds, wind screens wouldn't

complete, HippWrap came on site and constructed full containment. It came all the way down to the edges of the

parapet. In fact I had to crawl in to the corners to spray," Crispin explains. With crew and city protected, it was time to begin the process of protecting the historic building.
