RESCUE MISSION:

MORE THAN JUST A COSMETIC FIX FOR THE BEGICH, BOGGS VISITOR CENTER IN PORTAGE, ALASKA

POLYUREA SAVES ALASKAN VISITOR CENTER

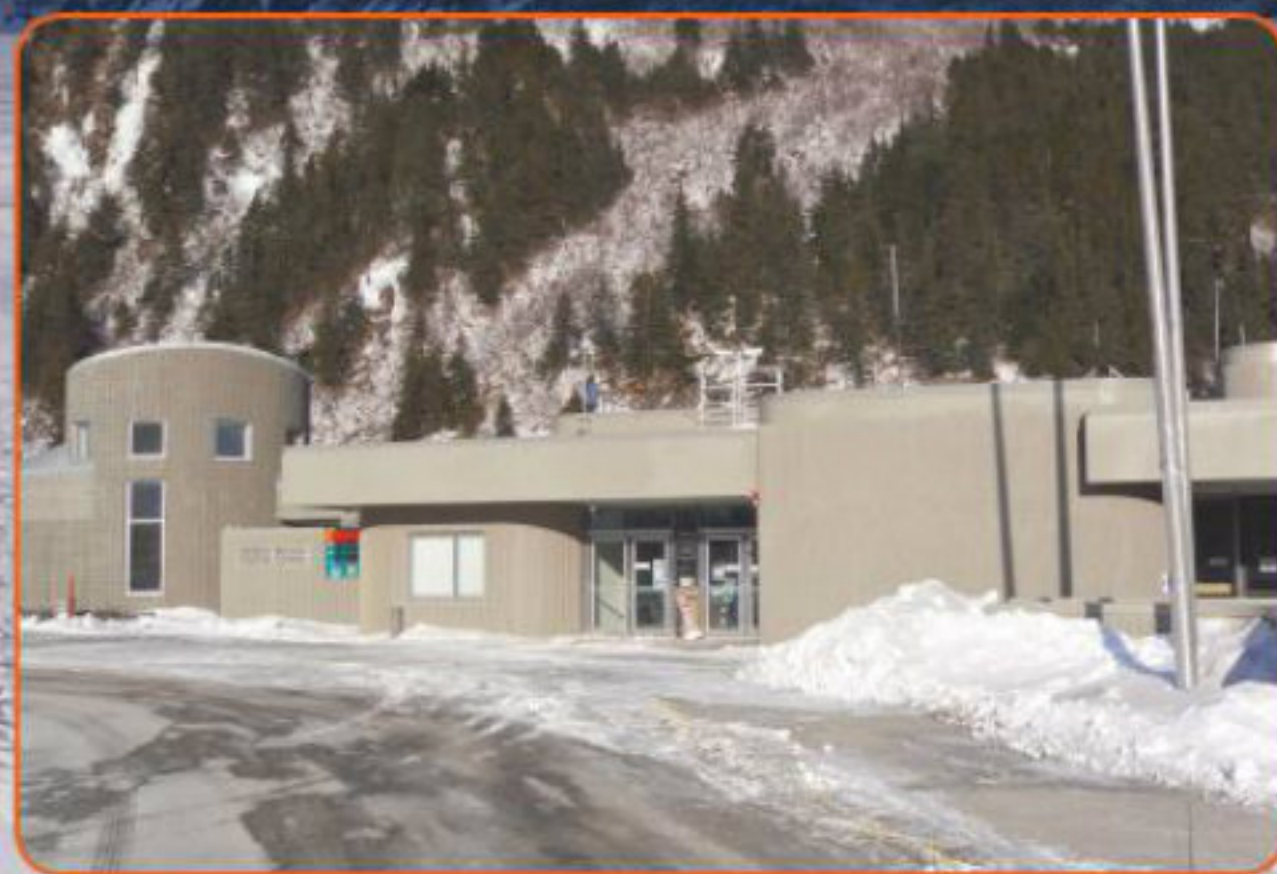
ABOVE ▲ After 25 years of wind, snow, and ice exposure, the Begich, Boggs Visitor Center in Alaska was in such bad shape that some concrete had eroded all the way down to the rebar. Would a typical coating be enough to permanently protect the building?

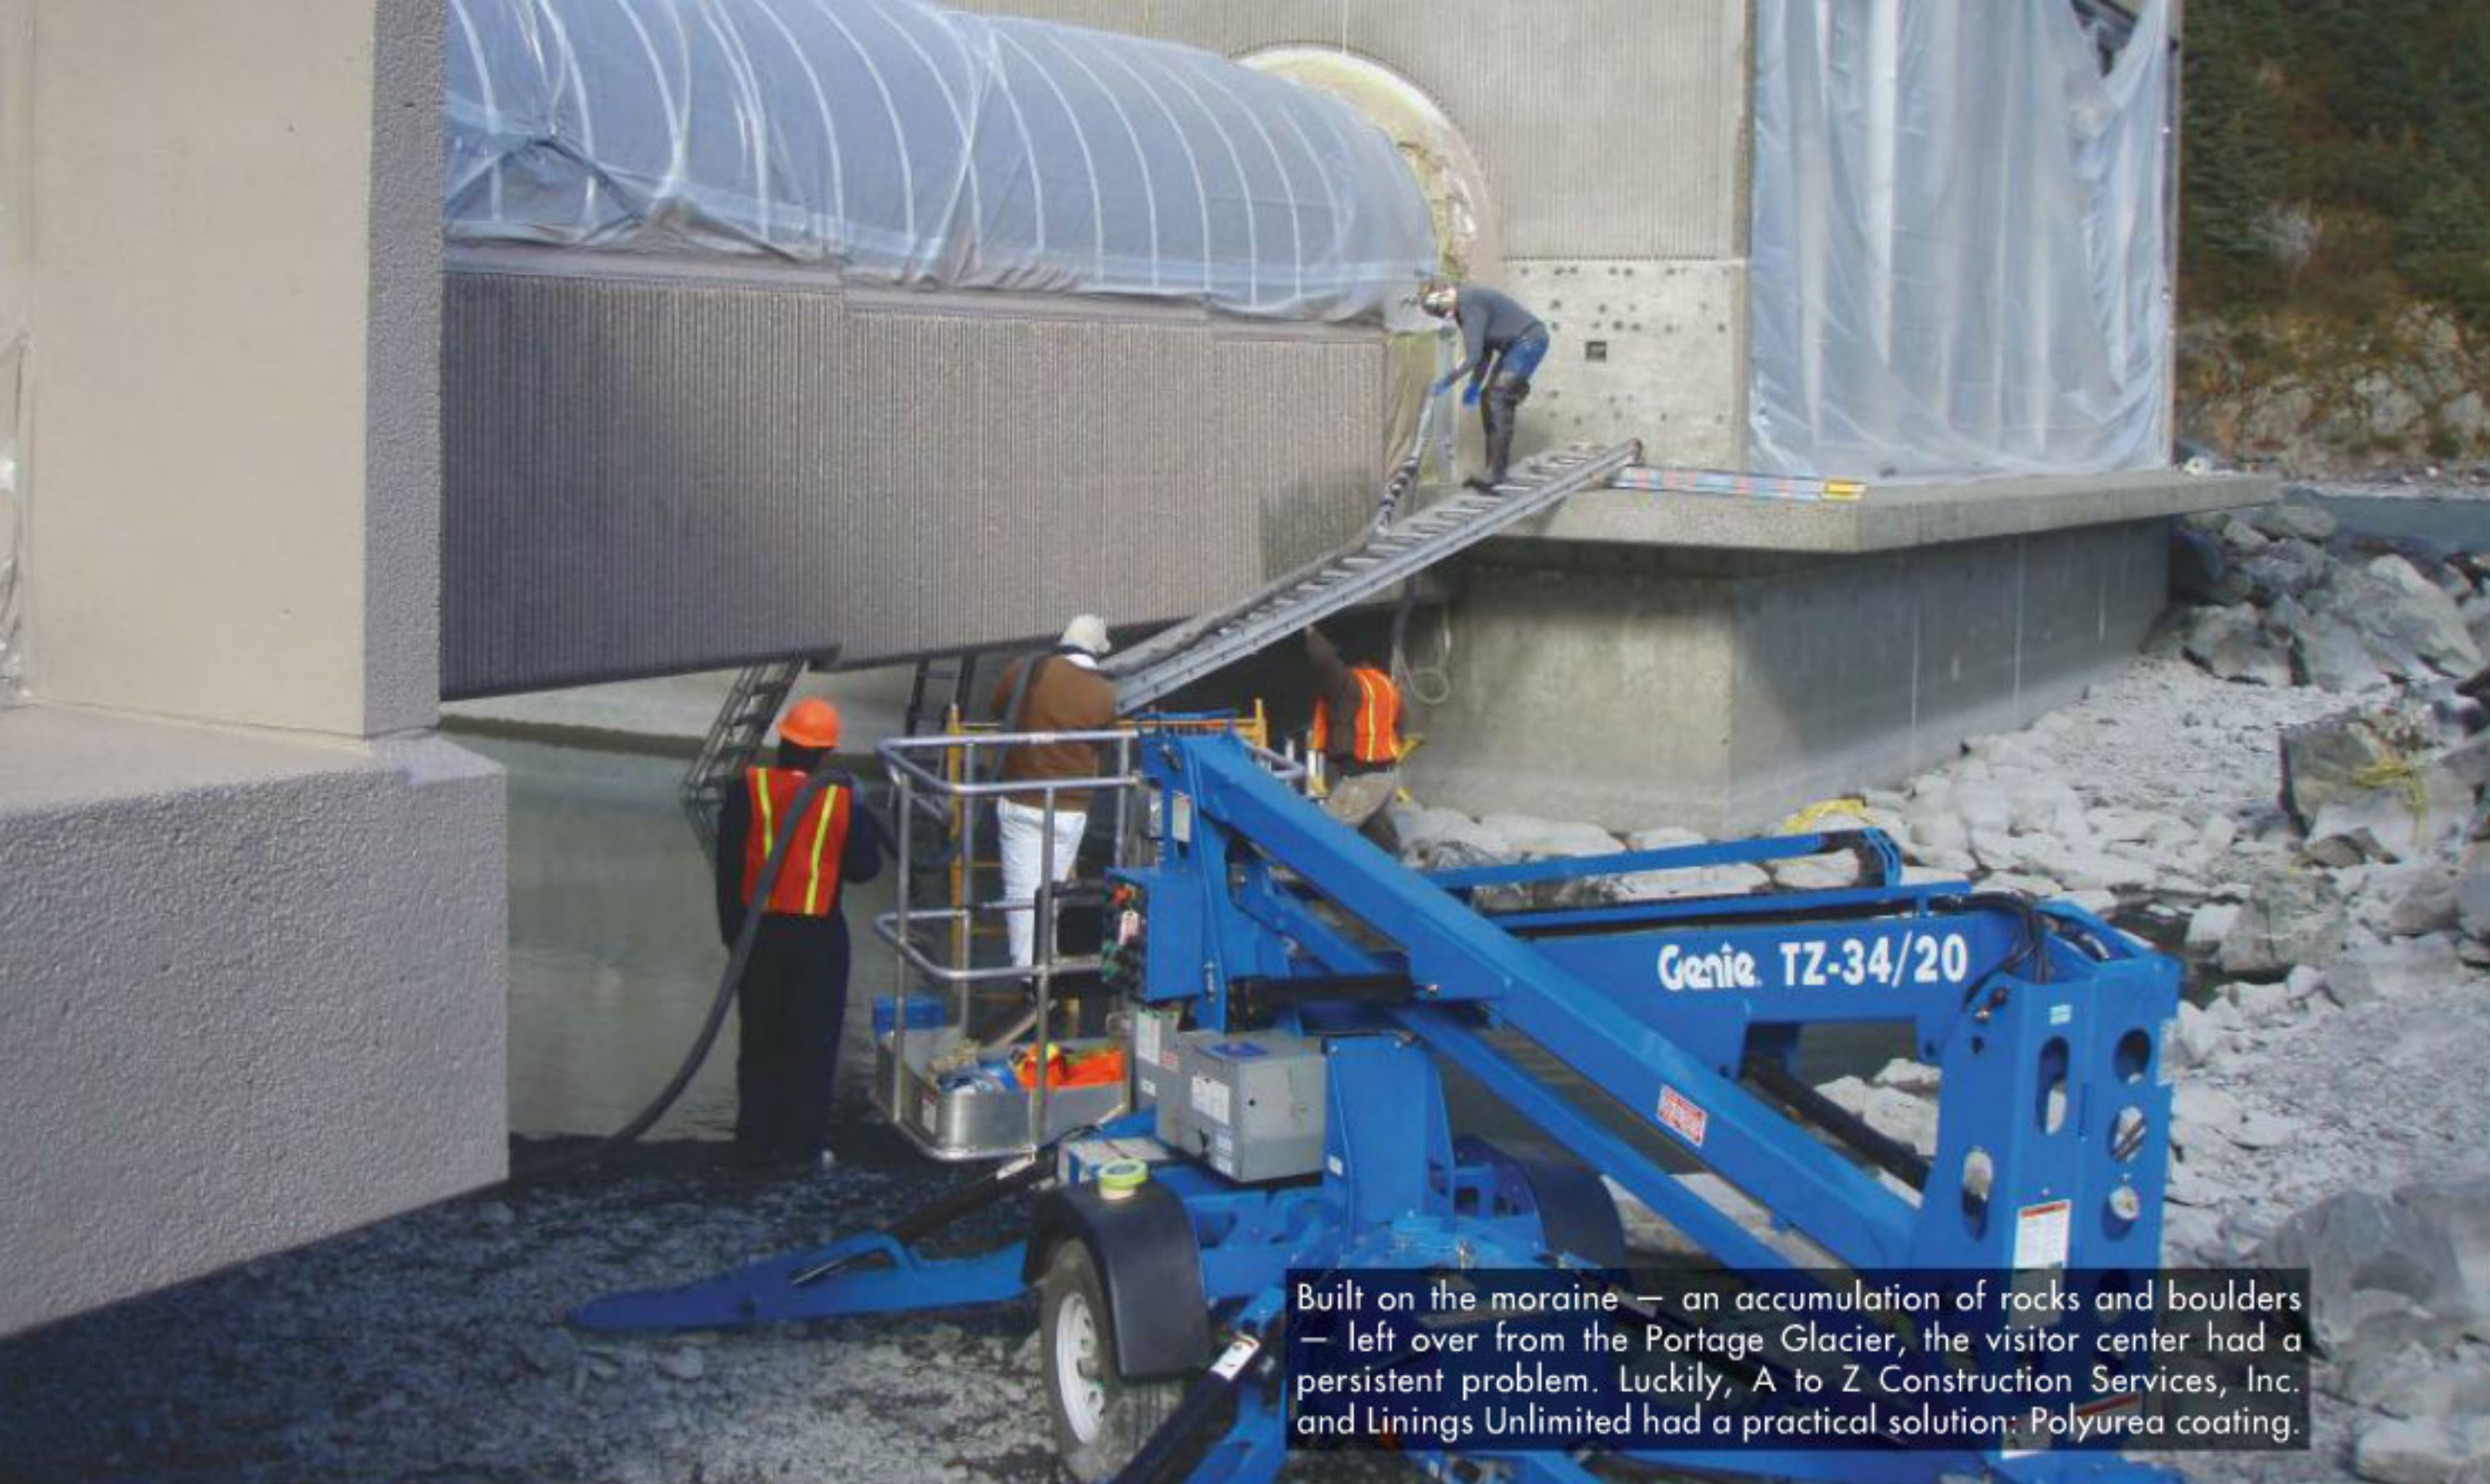
Built on the moraine — an accumulation of rocks and boulders — left over from the Portage Glacier, the visitor center had a persistent problem. Luckily, A to Z Construction Services, Inc. and Linings Unlimited had a practical solution: Polyurea coating.

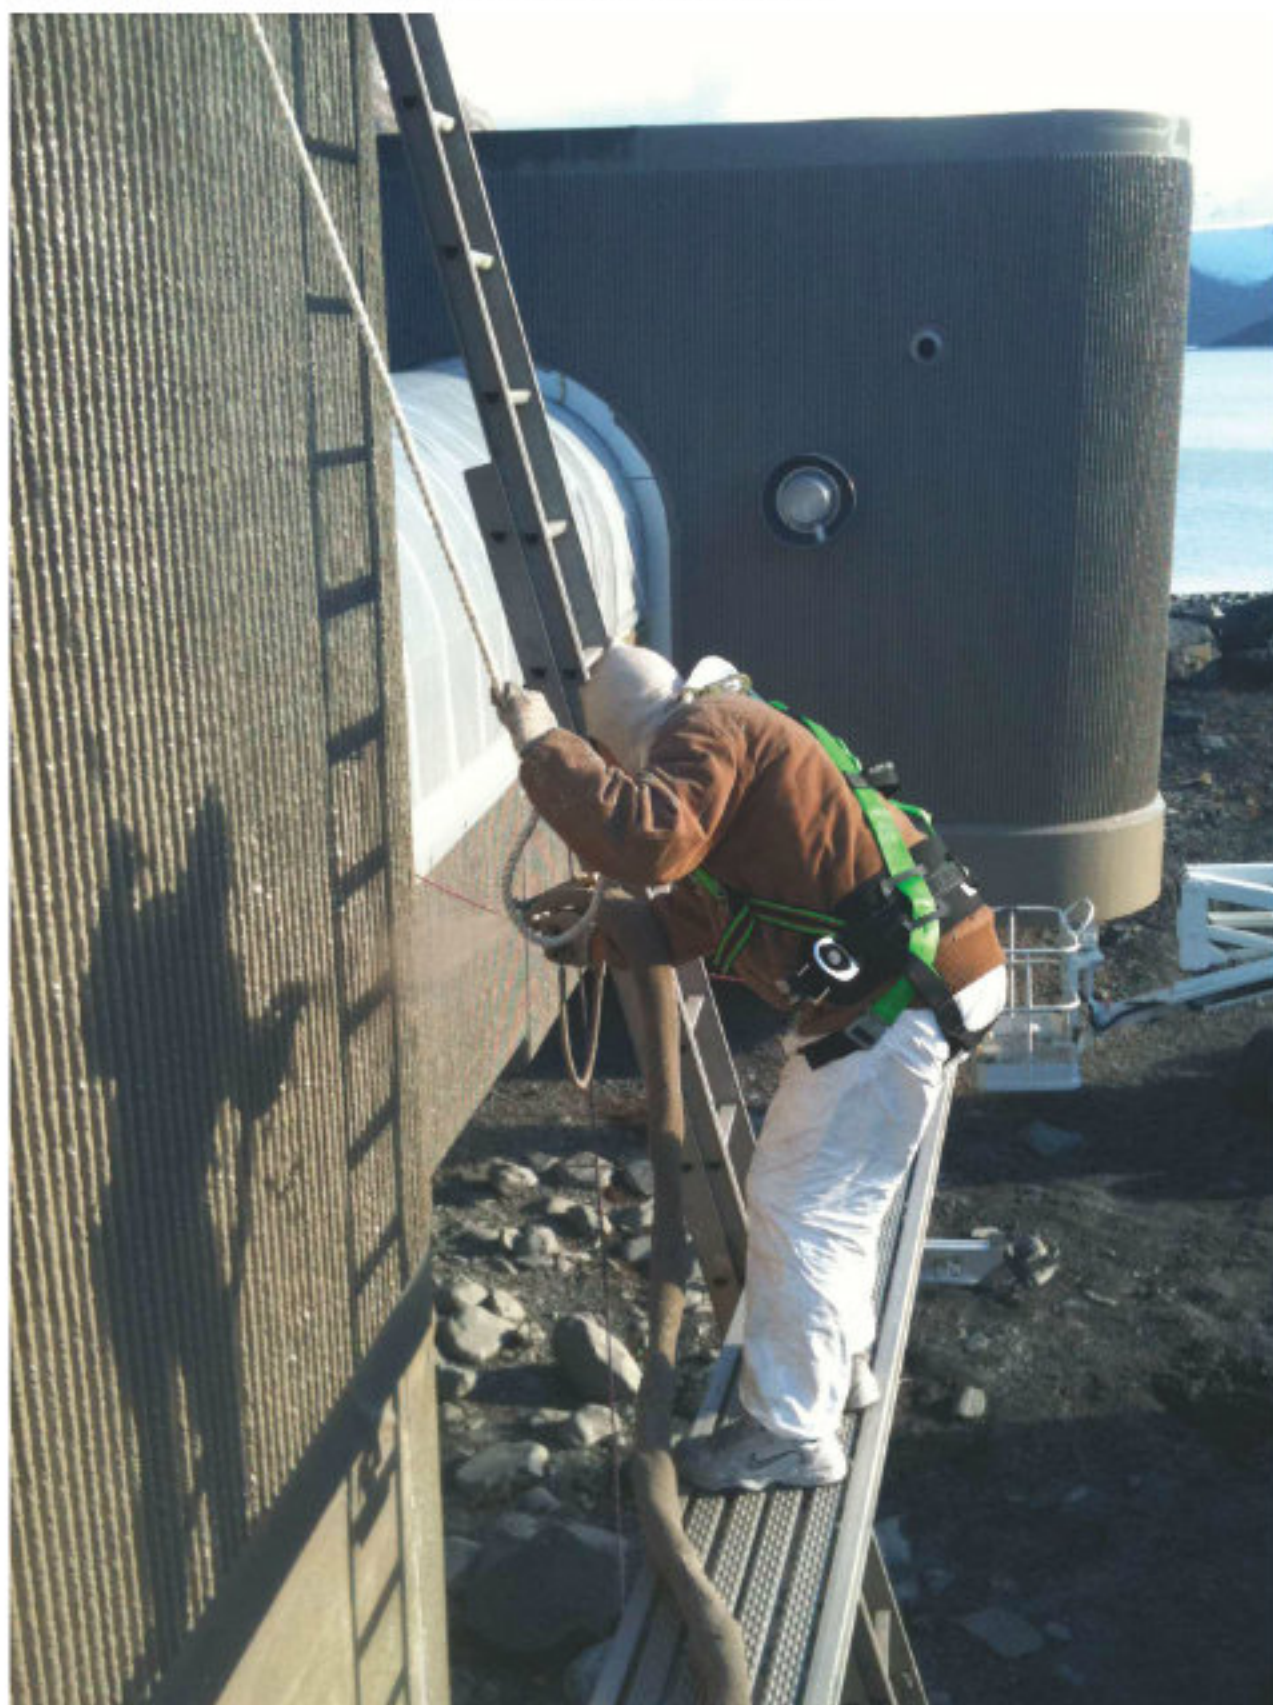
BELOW ▼ Once the U.S. Forestry Service (the owner of the visitor center) hired Linings Unlimited, a 7-to-9-man team came in to prep the concrete. They used a power washer to clean off all debris from the 13,500 sq. ft. (1,254.2 m²) of surfaces that were to be coated.

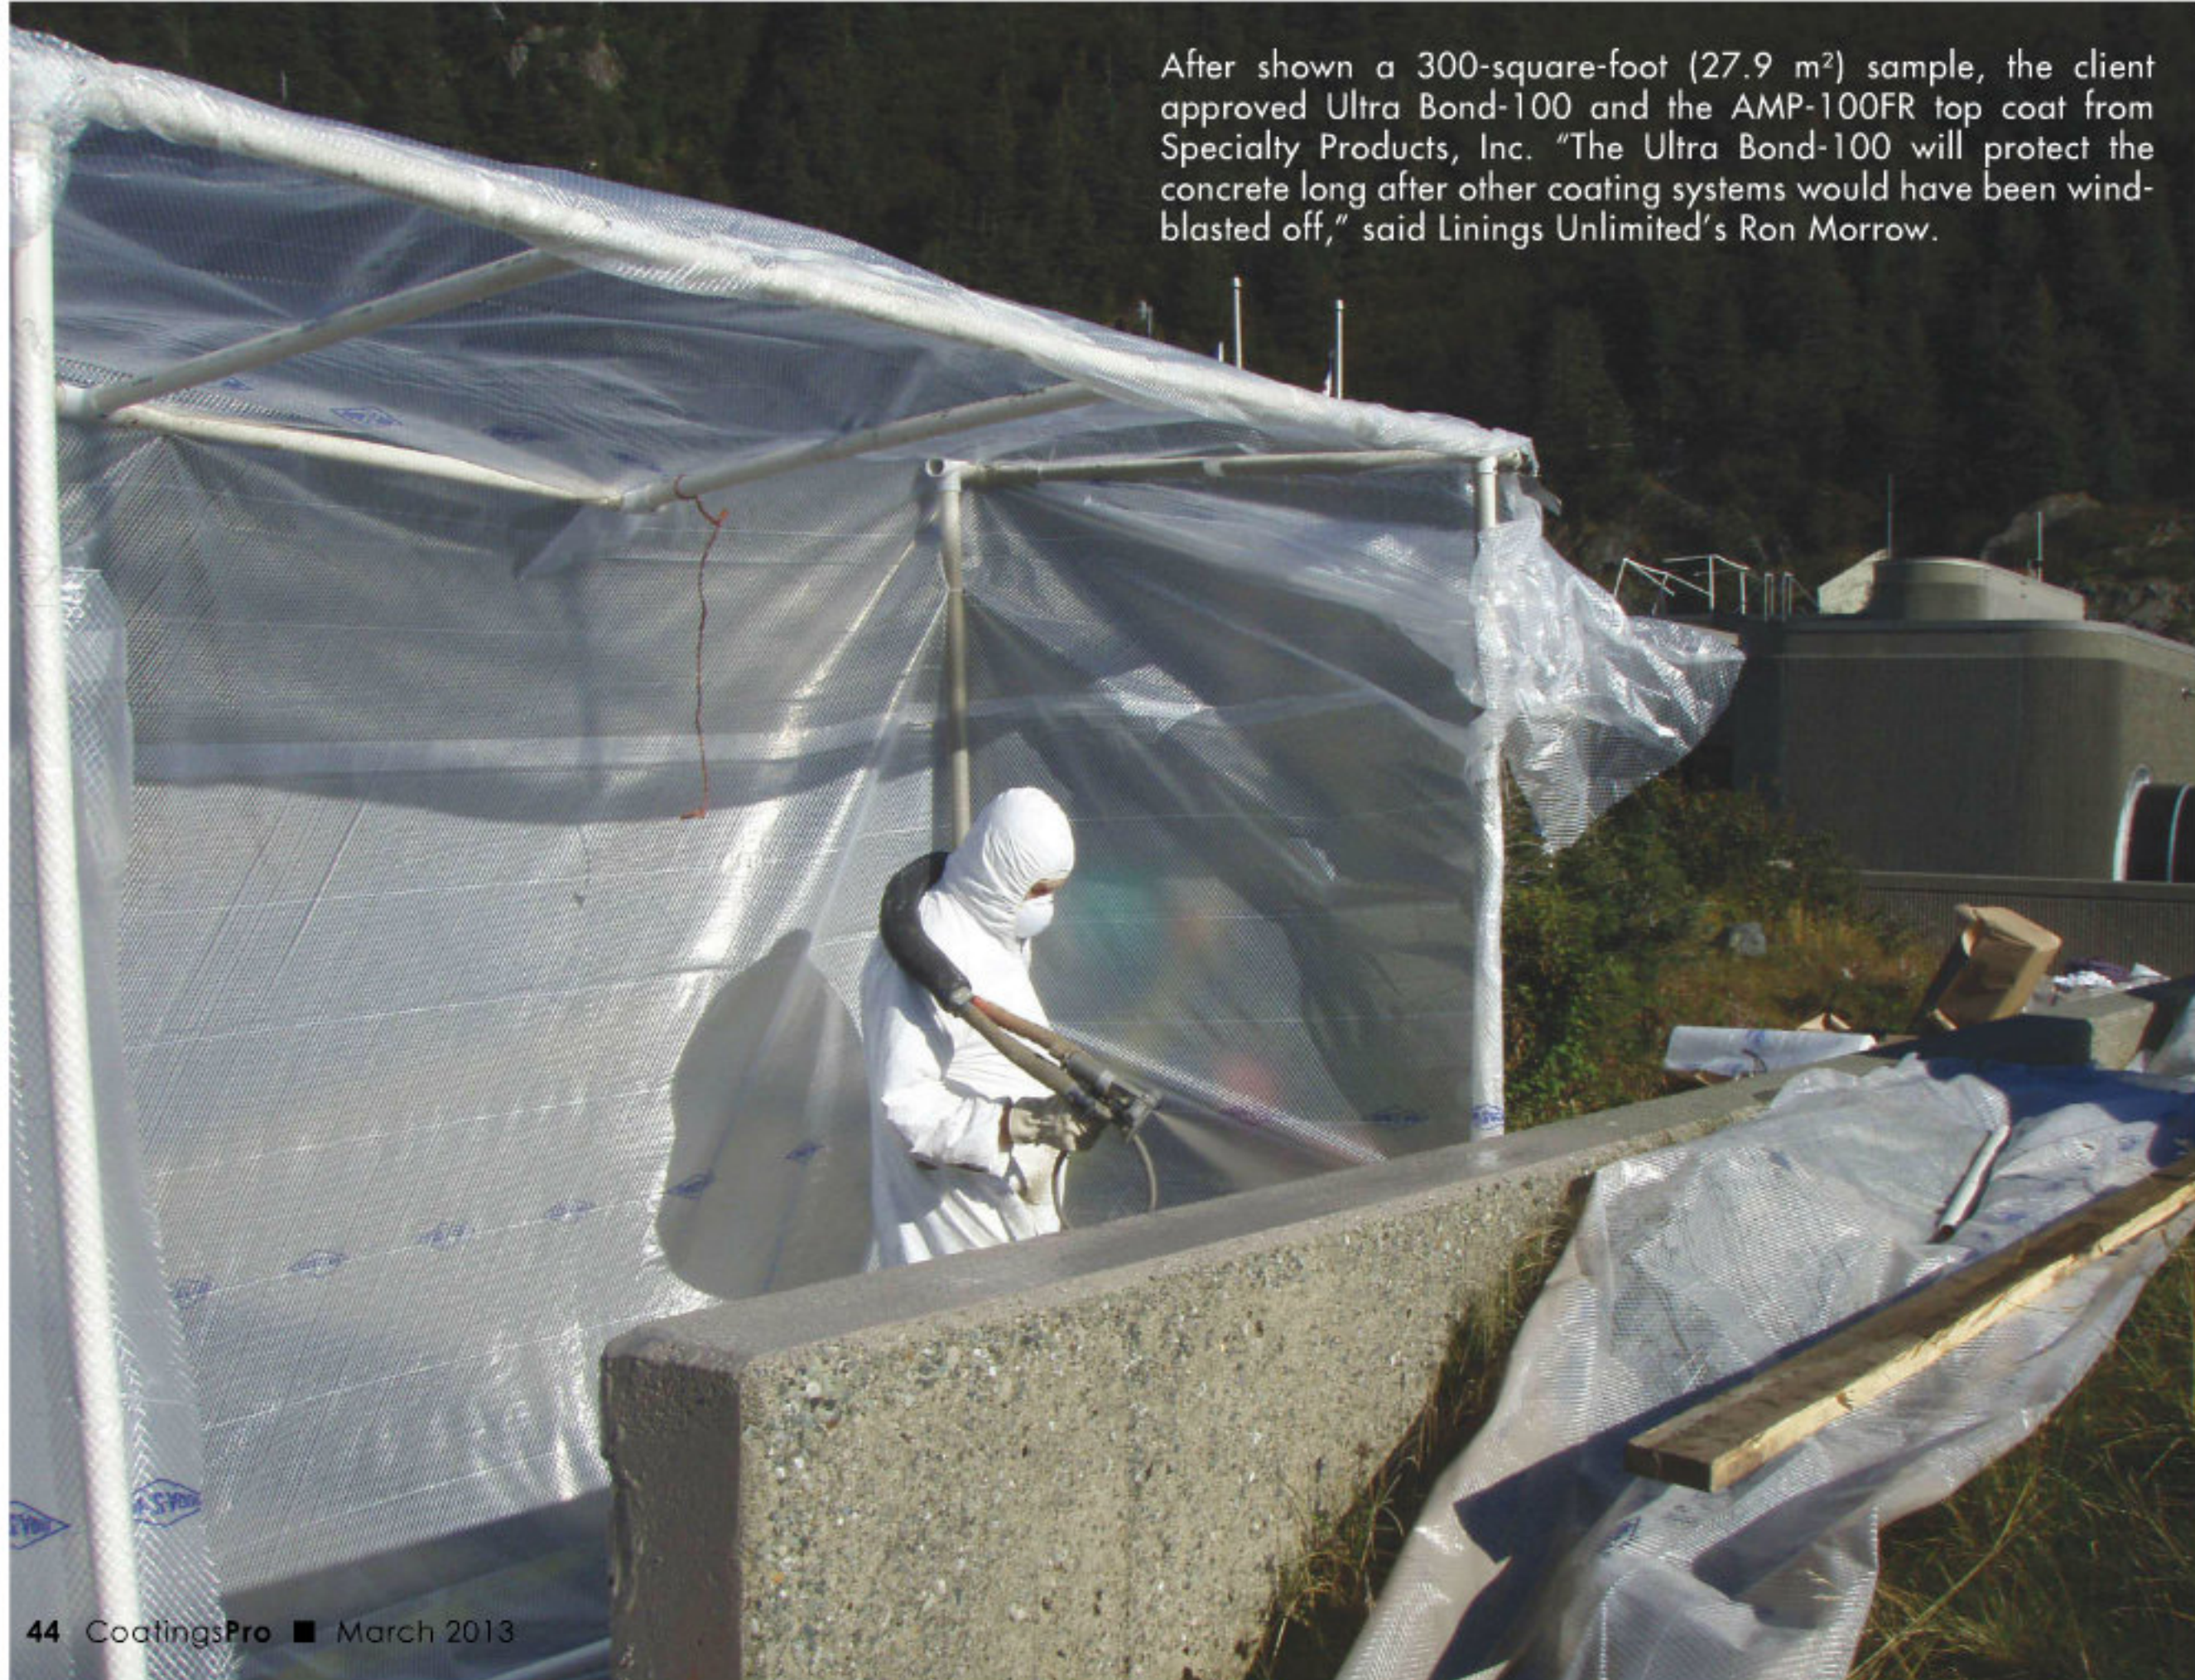
After shown a 300-square-foot (27.9 m²) sample, the client approved Ultra Bond-100 and the AMP-100FR top coat from Specialty Products, Inc. "The Ultra Bond-100 will protect the concrete long after other coating systems would have been wind-blasted off," said Linings Unlimited's Ron Morrow.

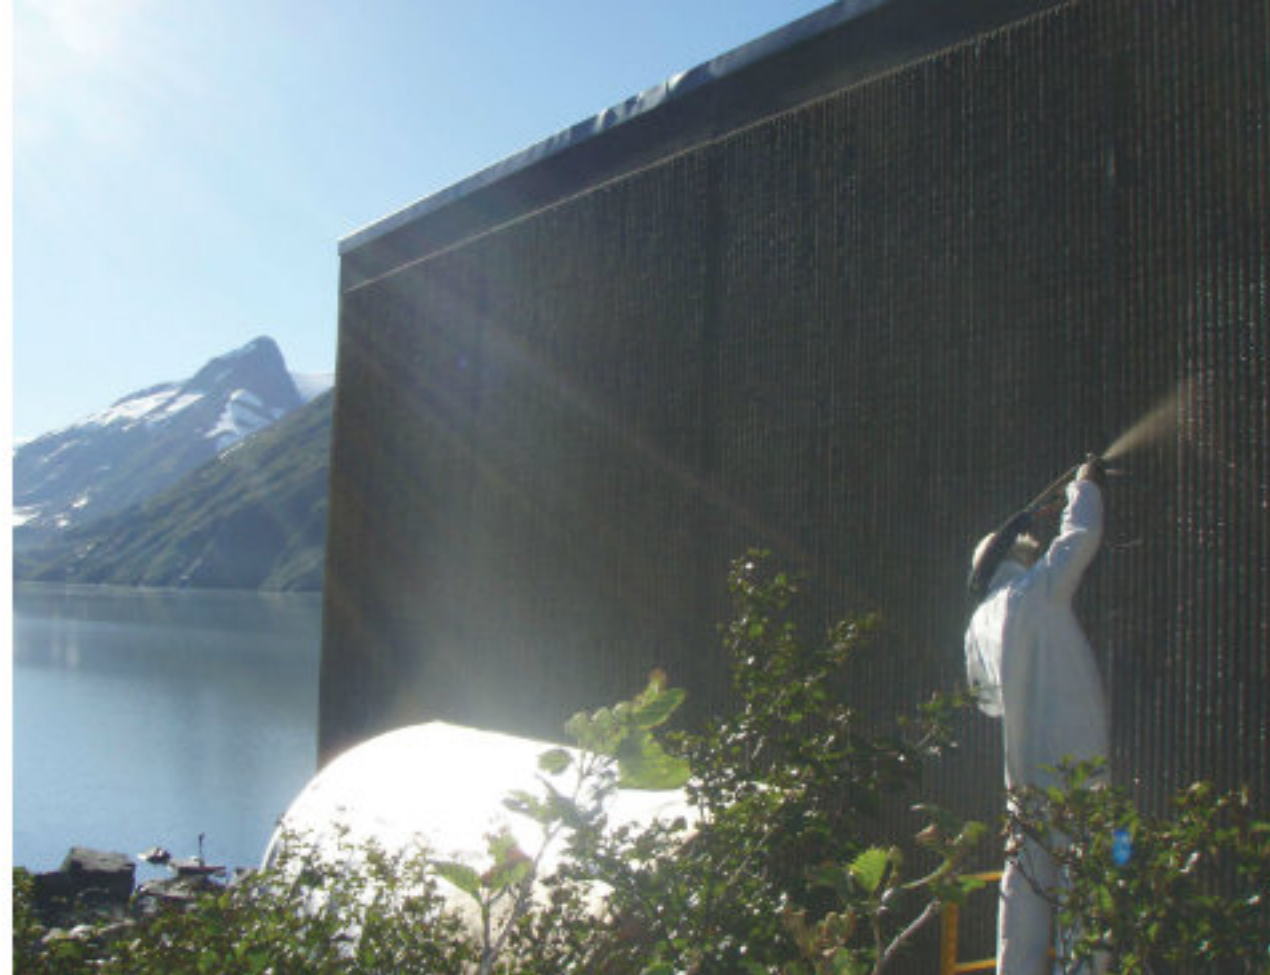
RIGHT ▶ Once prepped, the Linings Unlimited's crew applied the polyurea coating system at a 100-160-mil (2,540-4,064-micron) thickness using a Graco H20/35 Pro. All crew members wore safety goggles, respirators or particle masks, and Tyvek suits.

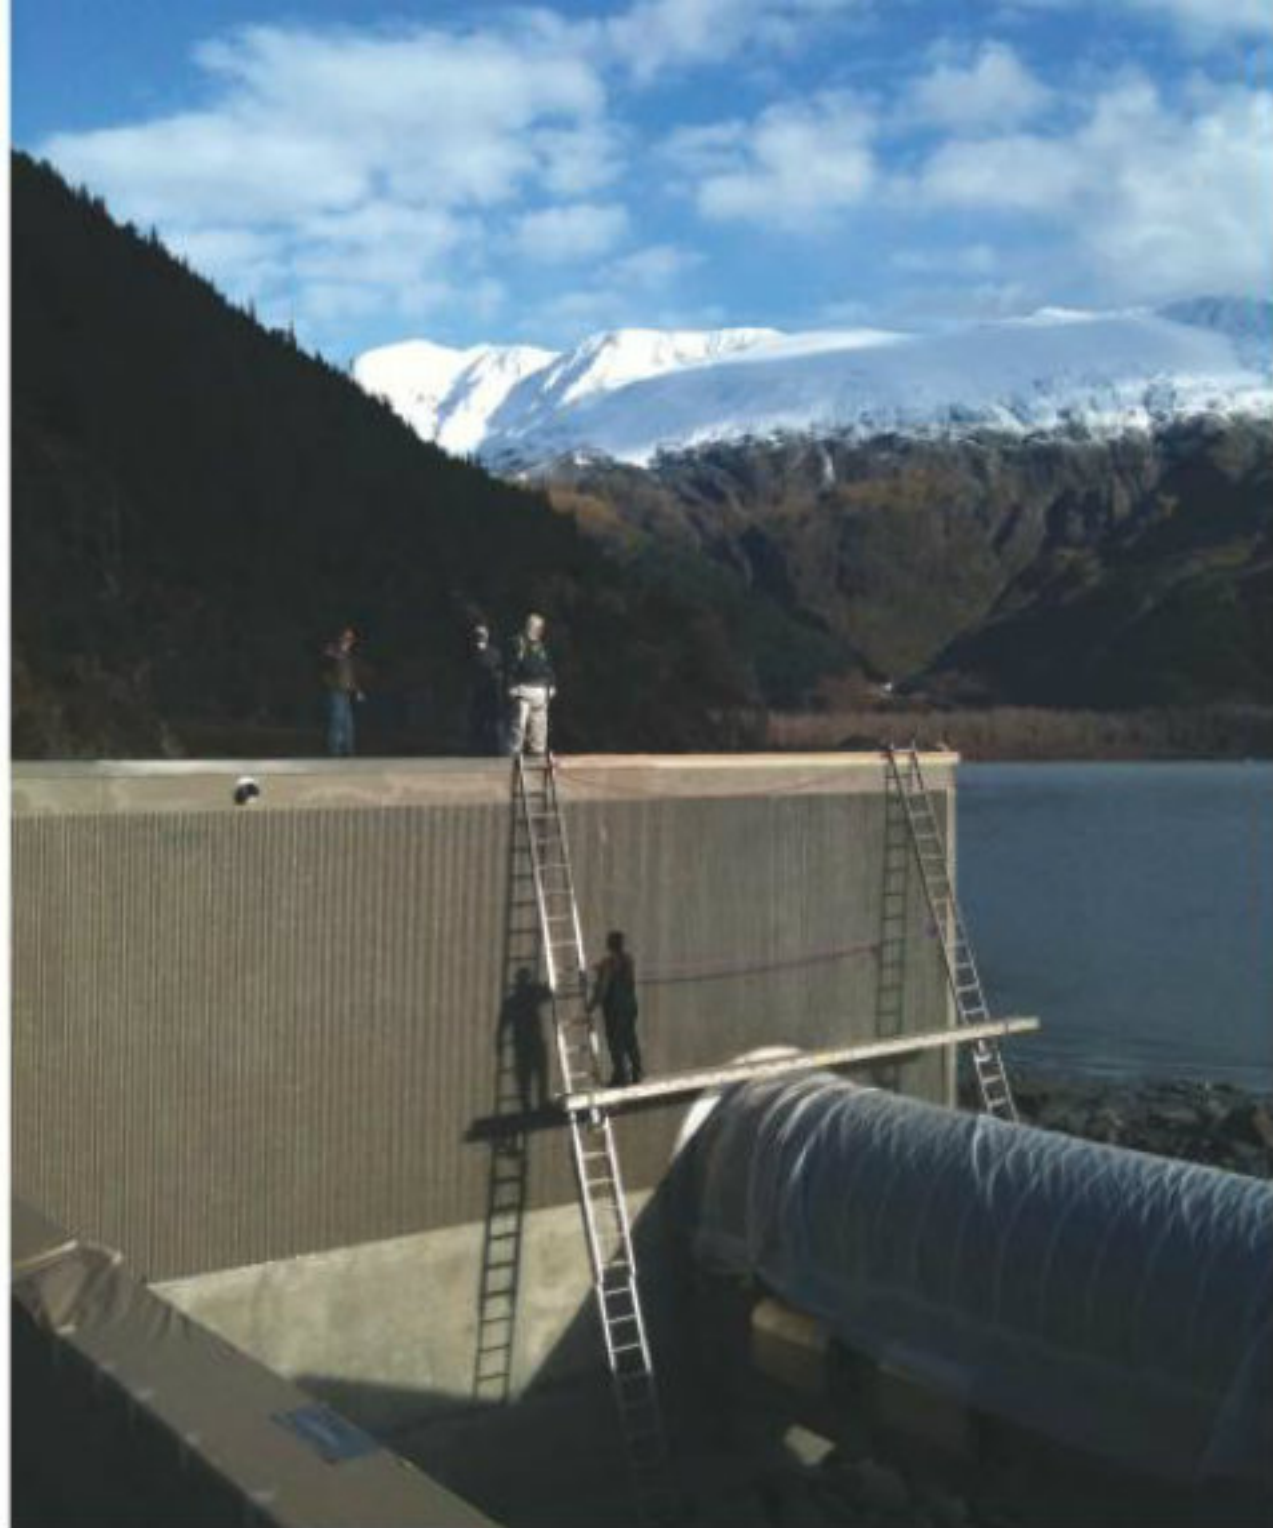
ABOVE ▲ "Sometimes I would be spraying from 35 or 40 feet (10.7 or 12.2 m) in the air on scaffolding or ladder racks," said Morrow. "Other times, I had to rappel on the side of the building. It took some moxie for me to spray in these conditions."

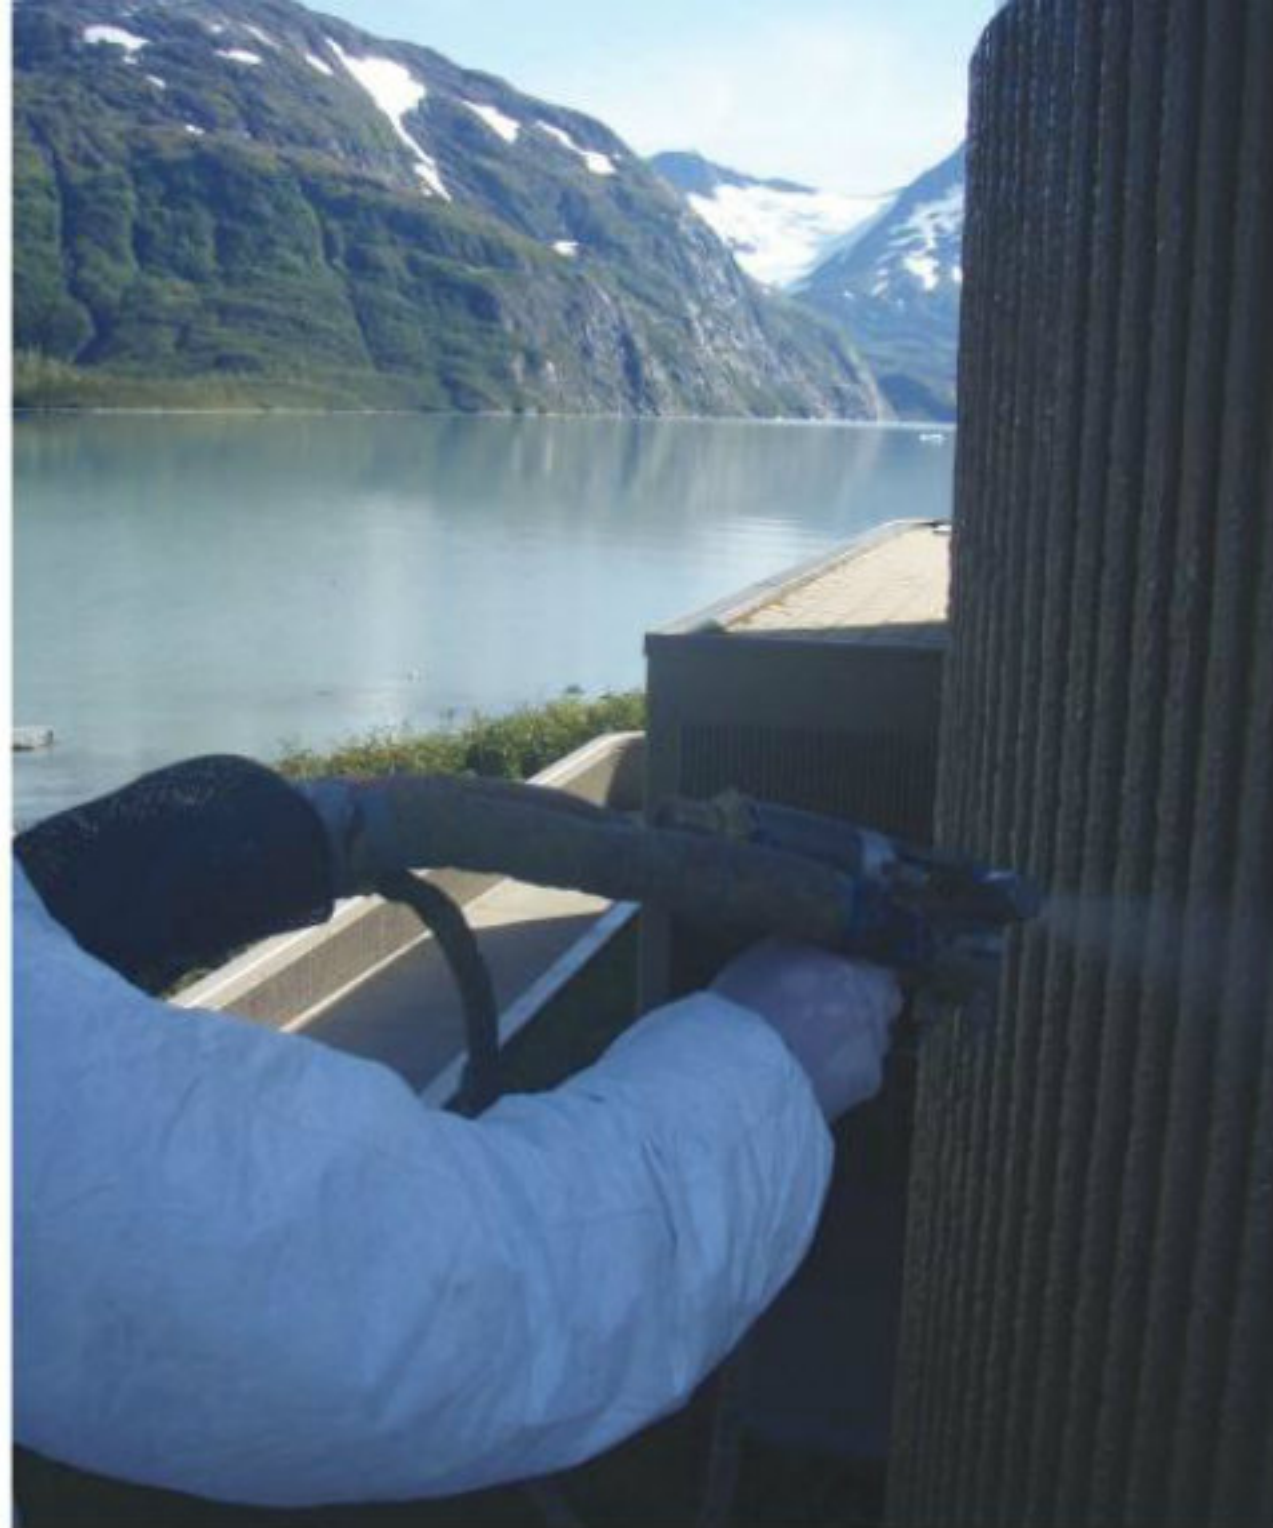
ABOVE ▲ At one point, rain filled the lagoon surrounding the visitor center and flooded the area, taking out a pricey piece of A to Z Construction Services' lift equipment. Luckily, everything else was salvageable, and the crew was able to finish the job within 12 weeks.
