VOC REGS DOD & HEX CHROME HYBRID FLOORING SYSTEMS

JULY 2011

# The Wrath Of Grapes:

## Coatings Resist Winery Mold

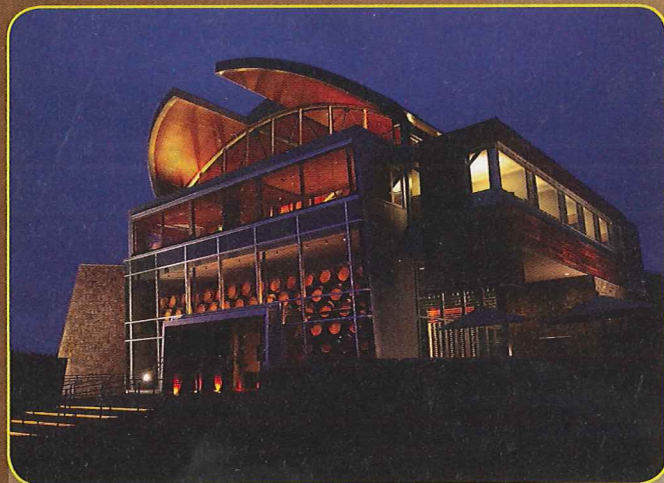
**ABOVE ▲** In their newly expanded estate building, The Williams Selyem Winery had almost 36,000 sq. ft. (3,344.51m<sup>2</sup>) of concrete, cinderblock, sheetrock, plywood, and steel that needed to be protected from the rising damp and the salty fog common to California's northern coast.

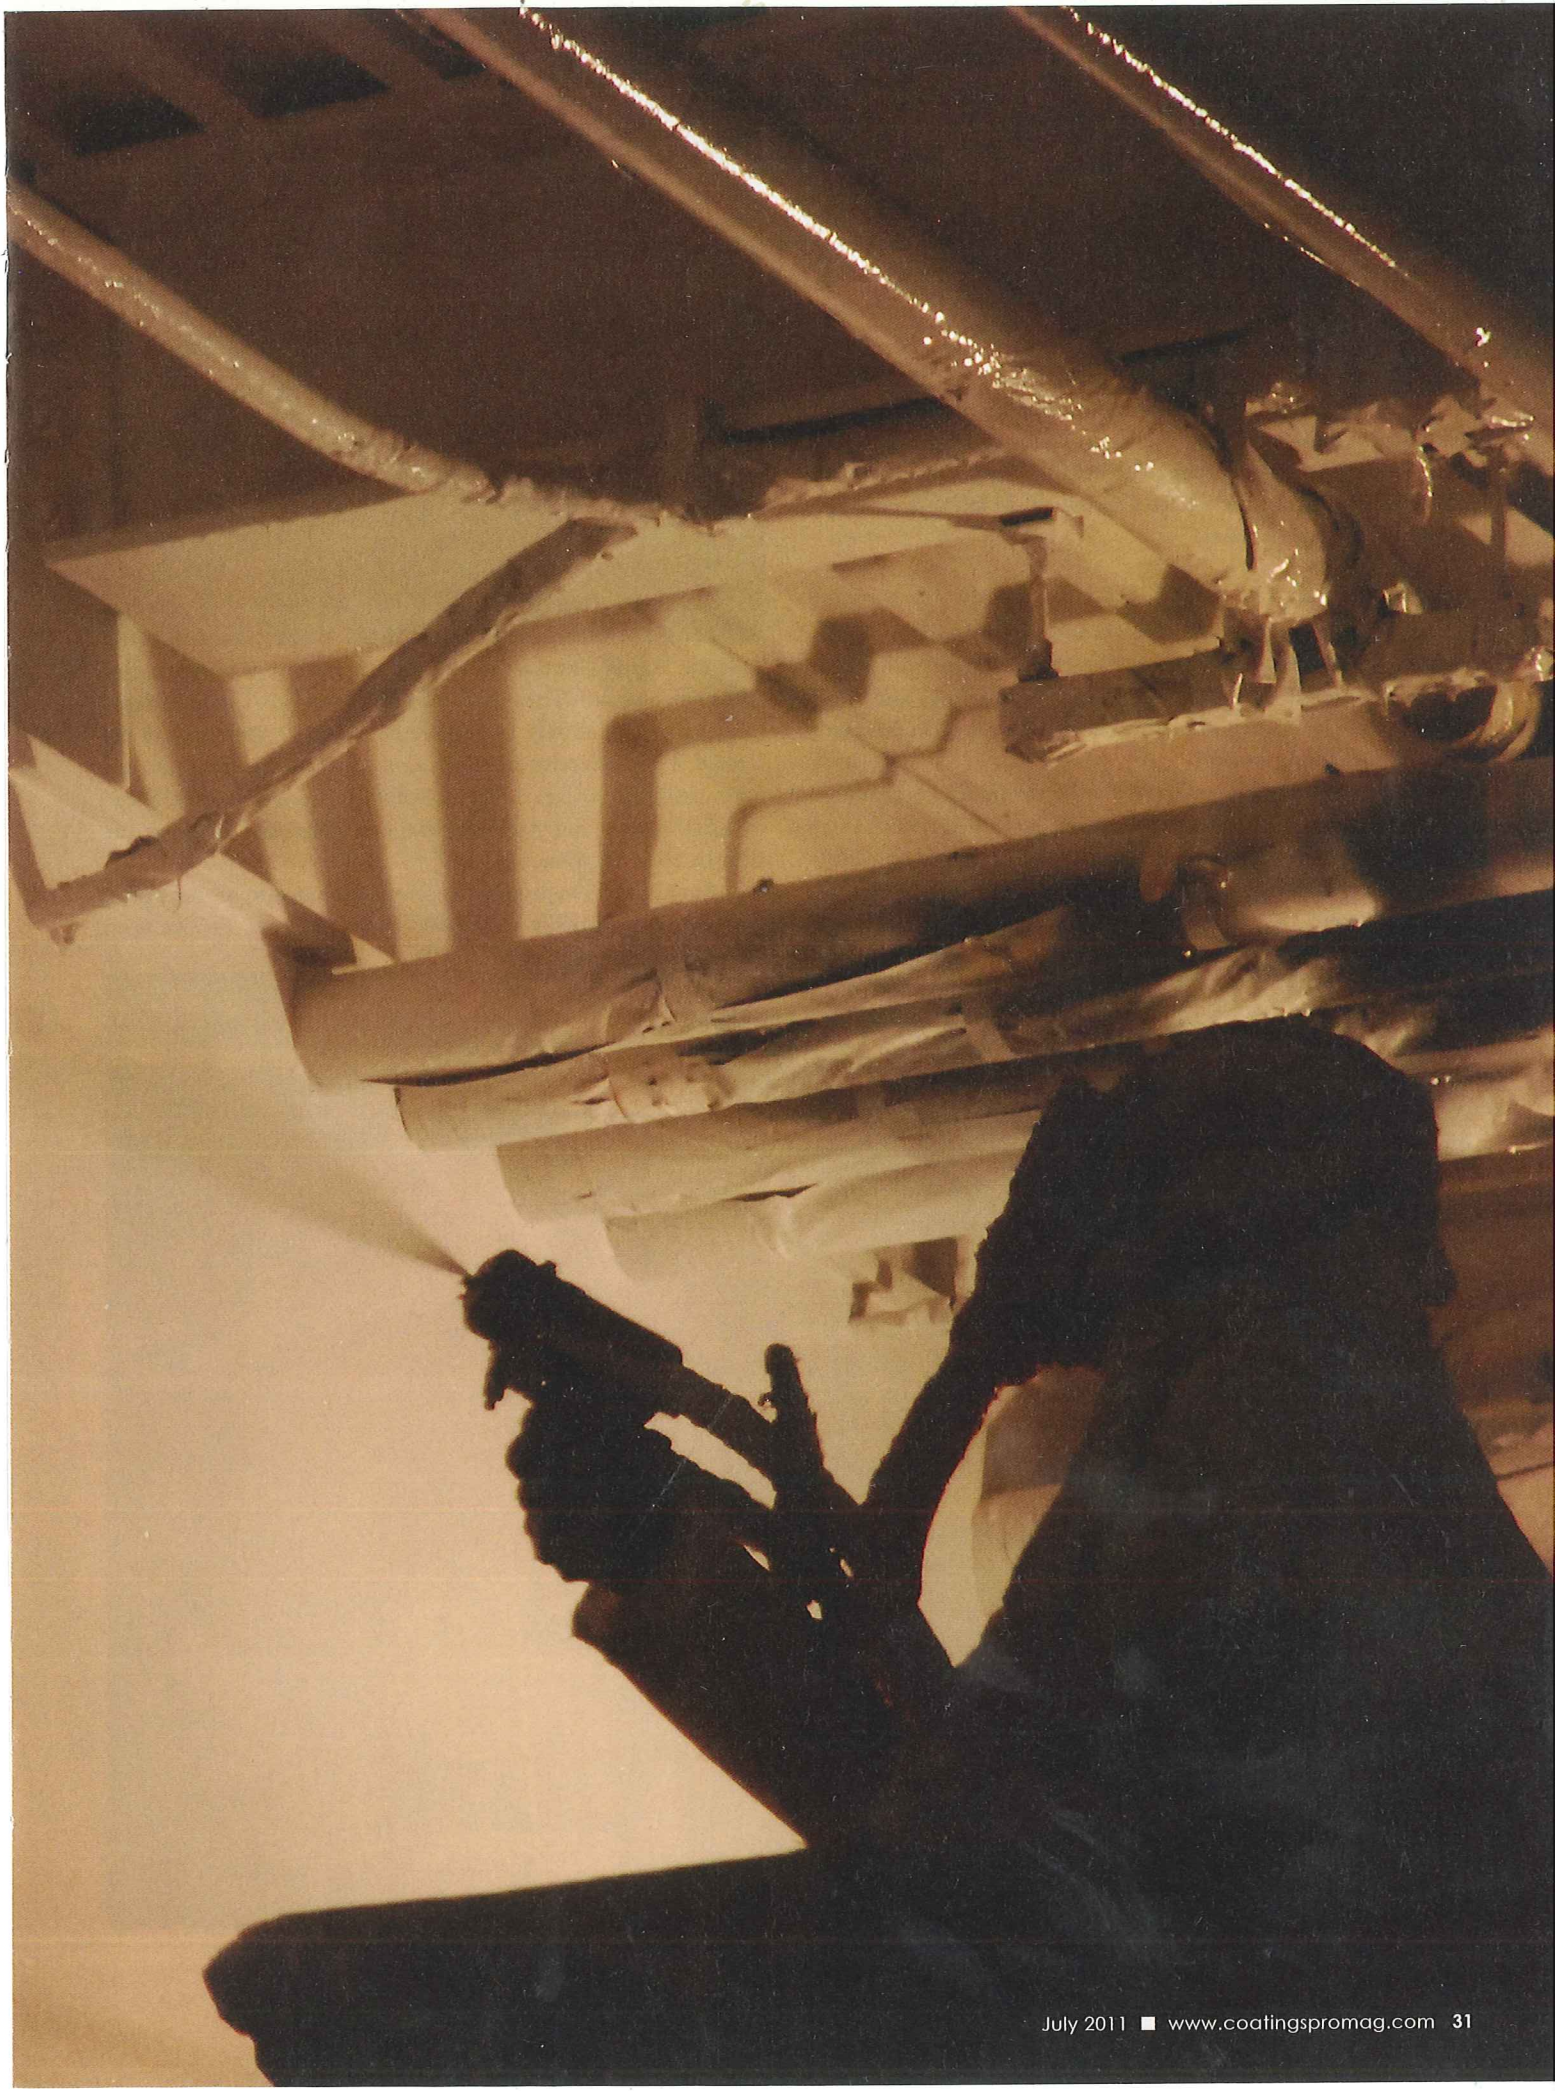
**RIGHT** ▶ Neocrete SL Polyurethane is specially formulated to resist acids and caustics—an important consideration given the floor's exposure to spilled wine.

Since the hall, lab, and production room floors would see high traffic and heavy abuse, the specifications called for a heavy-duty coating system—70800/70801/70804 Neocrete SL Polyurethane resurfacing system from Neogard. Neocrete SL (70800/70801/70804) is a water-dispersed polyurethane resin that combines with powder for use as a resurfacing system. The coating is specifically formulated to provide excellent resistance to abrasion, impact, chemical attack, acids, and caustics—important given the acidic nature of spilled wine. It also provides excellent performance against thermal shock stresses, such as hot water and daily steam cleaning. Also important, Neocrete SL is USDA acceptable.

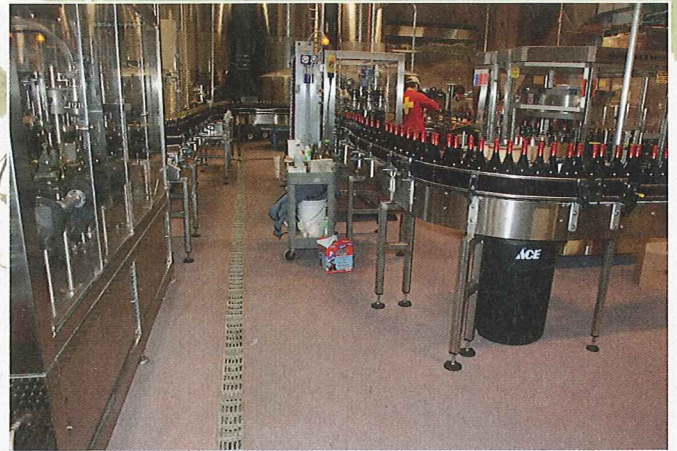
The production room was coated with a ¼” (0.64cm) thick coat of 70800/70801 Neocrete SL Polyurethane.

- Install Schuler Systems Ltd. stainless steel diminishing strips at end of cove in barrel tasting room
- Screed box and Hover trowel-apply 1/4" (0.64cm) thick coat of 70800/70801 Neocrete SL Polyurethane resurfacing system in hallway, lab, and production rooms

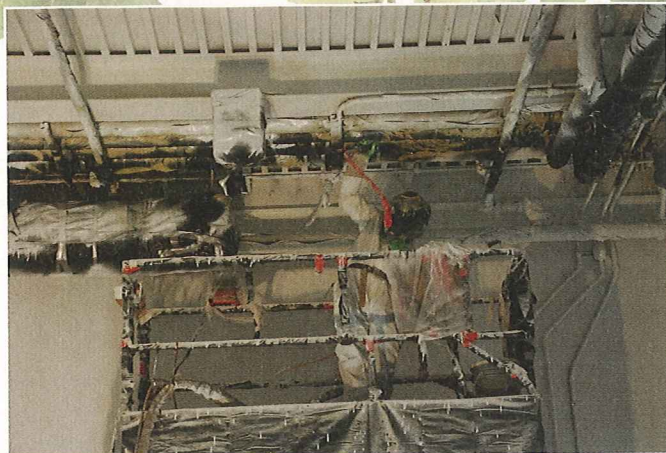
**ABOVE ▲** After the weep holes in the light-weight concrete and metal roof deck were caulked, the base coat of Polyshield HT 100F was applied at 40 mils (1.02mm) DFT.

The crew used SikaFlex 1A, a premium-grade, high-performance, moisture-cured, 1-component, polyurethane-based, non-sag elastomeric sealant to fill in the weep holes. The SikaFlex 1A was trowel-applied using paint scrapers.

“Once all of the weep holes in the lightweight concrete metal roof deck had been caulked,” Burk continues, “we applied the mold- and mildew-resistant base and top coat on the ceilings.”

First they spray-applied a 40-mil (1.02mm) DFT base coat of Polyshield HT-100F using a Graco Reactor proportioner and a Fusion gun. From SPI, the 100% solids elastomeric polyurea has no solvents—an important consideration in a winery. Also, Polyshield HT-100F is FDA/USDA compliant for incidental food contact. This coating is often specified for use in tanks, silos, and pipes because of its ability to form a monolithic membrane with excellent water- and chemical-resistance—an important consideration given the winery's location and the often damp conditions inside and out.

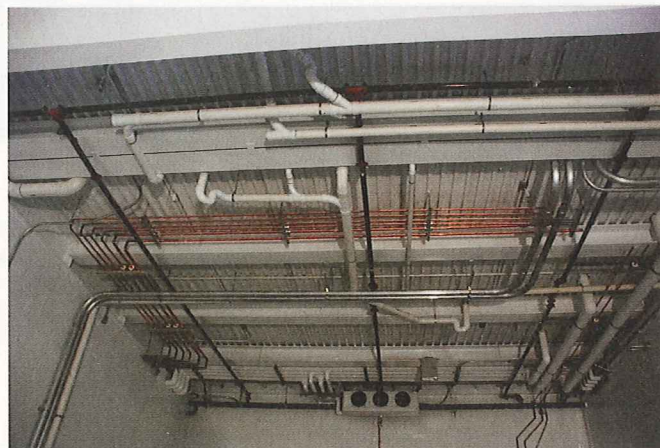
**ABOVE ▲** A 20-mil (0.51mm) DFT top coat of HardCap-100 spray-applied onto the ceilings using a Graco Reactor proportioner and a Fusion gun.

The base coat was followed by a 20-mil (0.51mm) DFT top coat of HardCap-100 spray-applied onto the ceilings using the same equipment—cleaned first, of course. Also from SPI, the 100% solids clear aliphatic polyurea contains no solvents and qualifies for USDA incidental food contact applications. Since it is available from the manufacturer with a microbial-resistant additive to minimize mold and mildew growth, it is often specified for use in clean rooms, hospitals, and food and beverage facilities, such as this winery.

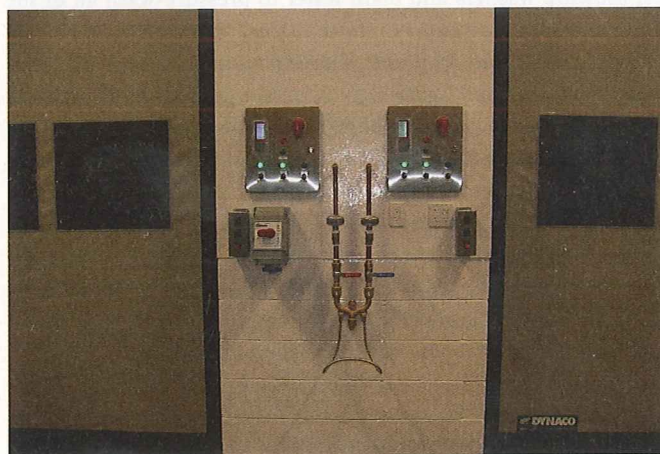
**RIGHT ▶** The sheetrock walls were coated with a 50 mil (1.27mm) DFT base coat of Polyshield HT 100F and 20 mils (0.51mm) DFT of Hard Cap-100. The cinderblock walls were coated with an 80 mil (2.03mm) DFT base coat and a 20 mil (0.51mm) DFT top coat of the same materials.

This was followed by a spray-applied base coat of Polyshield HT-100F at 80 mils (2.03mm) DFT. When the base coat had cured, the crew spray-applied a 20-mil (0.51mm) DFT top coat of Hard Cap-100.

For the sheetrock walls, the crew simply spray-applied the base coat of Polyshield HT-100F at 50 mils (1.27mm) DFT using the Graco H-40 proportioner and Fusion gun. This was followed by a top coat of Hard Cap-100, spray-applied at 20 mils (0.51mm) DFT.

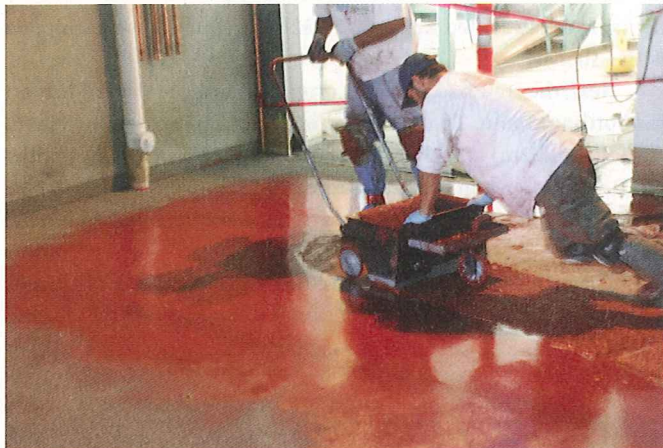
**ABOVE ▲** The crew uses a screed box to insure that the Neocrete SL Polyurethane system is applied at 1/4" (0.64cm) uniform thickness.

Setting up a mixing station, the crew first mixed 90 fluid ounces of 70800 with 63 fluid ounces of 70801 and one bag of 70804 powder. The three-part mixed urethane flooring was then transferred to a screed box and Hover trowel-applied to a 1/4" (0.64cm) thick coat.

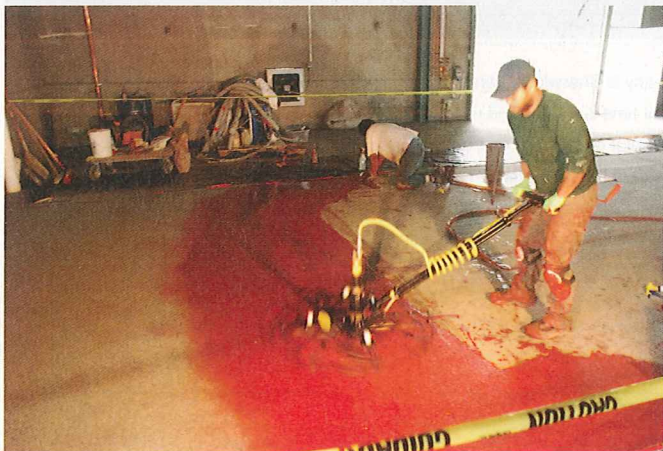
**LEFT ▲** Larger areas of the floor were power troweled using Hover trowels.
