**PROJECT:**  
Lewis Street Underpass Spall Repair

**LOCATION:**  
Pasco, WA

**OWNER:**  
City of Pasco Public Works Department

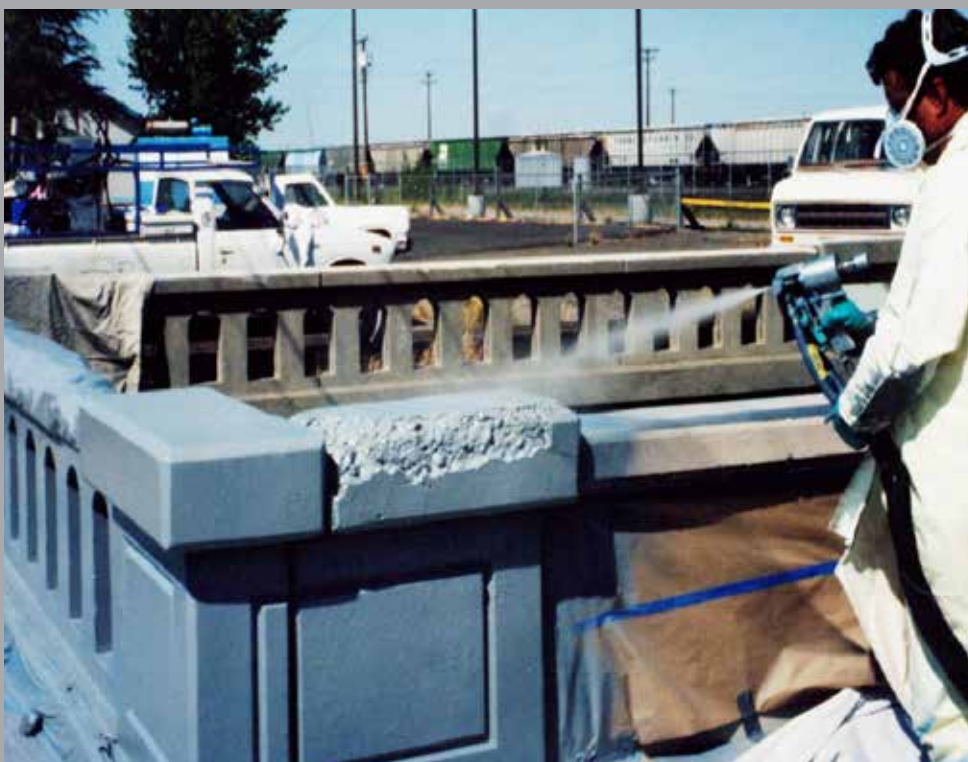
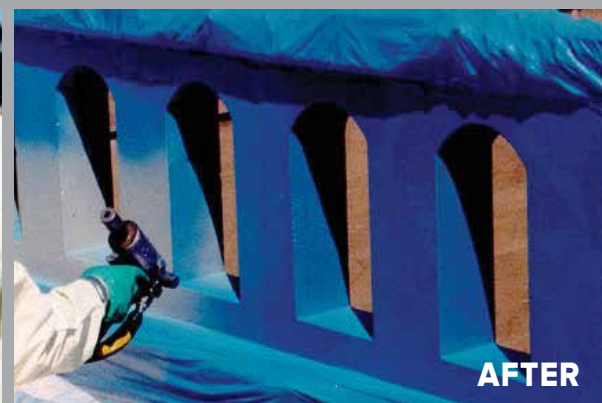
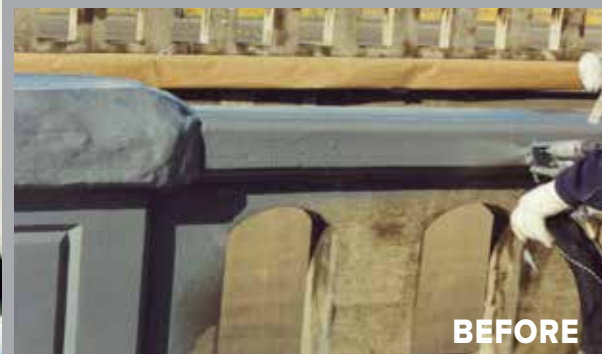
The Lewis Street Underpass was built in the 1930's with a low grade concrete. The concrete railing was spalling and falling on the cars below. Until the underpass could be replaced in the next 5-10 years, the city of Pasco needed an economical way to prevent the spalling. Because the underpass has a high volume of pedestrian and automobile traffic, a major concern for the project engineer was a quick turnaround time.

Polyshield SS™ 100 was chosen for its strength and quick curing time. In order to create a more even rail surface, the concrete was first hydro-blasted at 10,000 psi, then primed with three coats of Devoe 167

penetrating sealer. Next, a quick-set grout was used to fill the larger gaps on the rail cap. Another coat of penetrating sealer sealed the grout. The rail caps were then coated with 120 mils of Polyshield SS™ 100 and the vertical rail surfaces were coated with 60 mils.
