**PROJECT:**  
Deionized Water Tanks

**LOCATION:**  
Magna, Utah

**OWNER:**  
Large Copper Mines

**SYSTEM:**  
60-80 mils (1½-2mm)  
**POLYSHIELD SS™ 100 Polyurea**  
Standard Grey Color

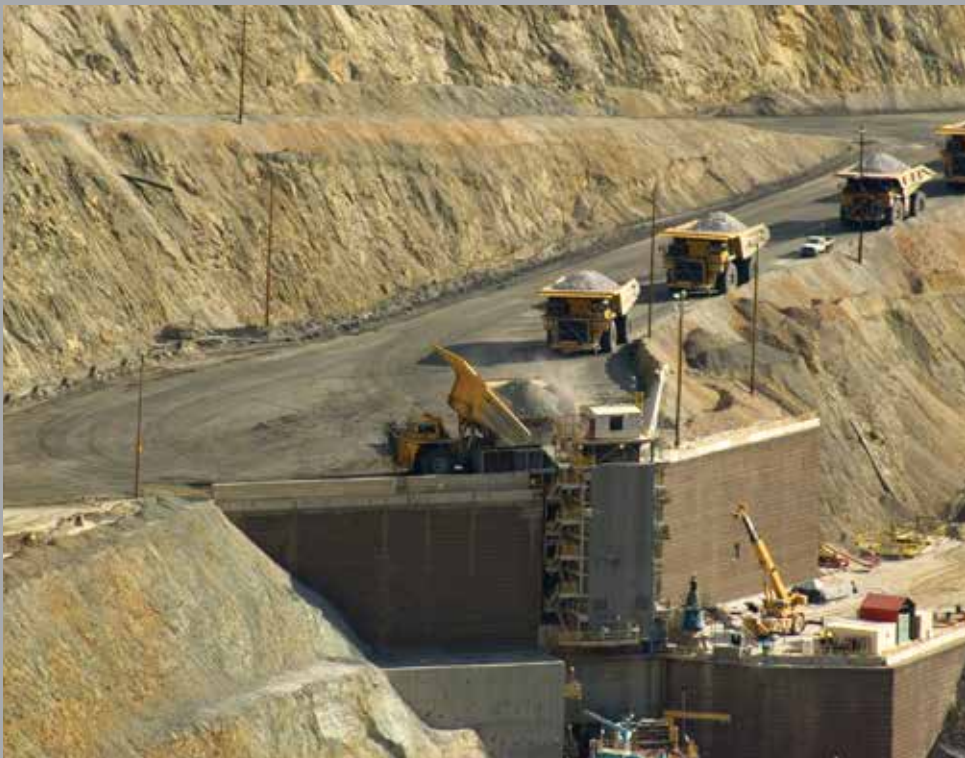
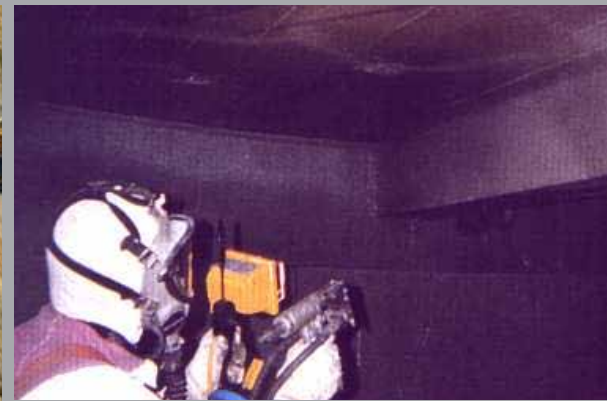
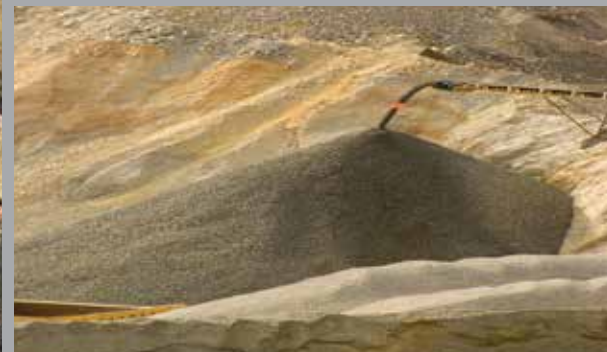
Mine personnel discovered leaks in two concrete storage tanks. The tanks were originally used to store lime solution and were being converted for deionized boiler water storage. When the tanks were first converted the mine owner lined the floors and walls with an epoxy coating. Subsequently, when the tank was filled with water, leaks were observed. The epoxy had failed and they needed a superior solution.

The inside of epoxy-coated concrete storage tanks were grit-blasted, followed by epoxy grouting in areas that were cracked. Then Polyshield SS™ 100 polyurea was applied at 60-80 mils (1½-2mm) on the tank floors and walls.
