PROJECT:
Restoration of Metal
Irrigation Flumes

LOCATION:
Kennewick, WA

OWNER:
Columbia Irrigation District

SYSTEM:
Polyshield SS™ 100

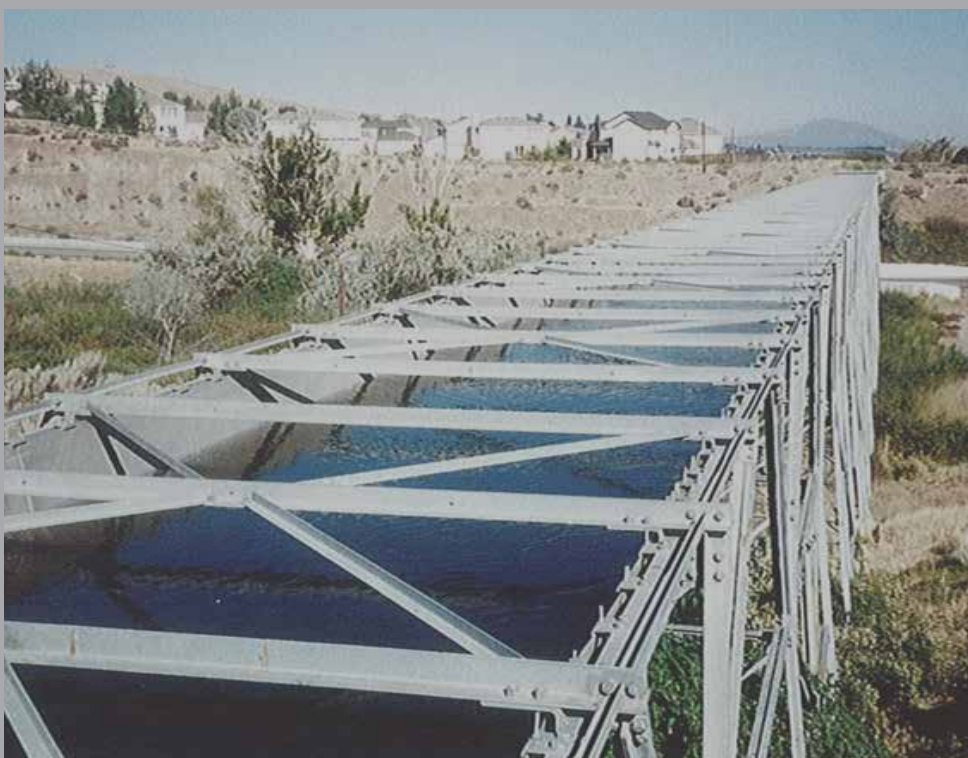
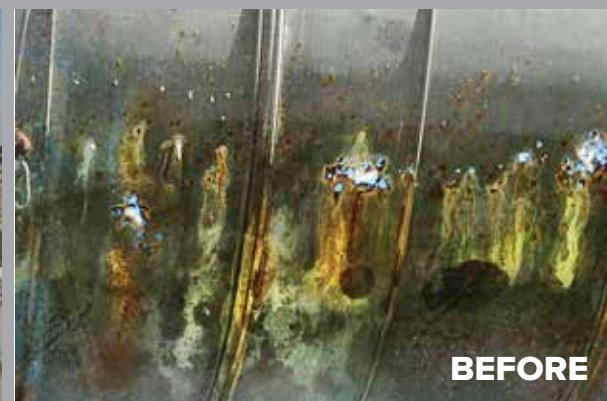
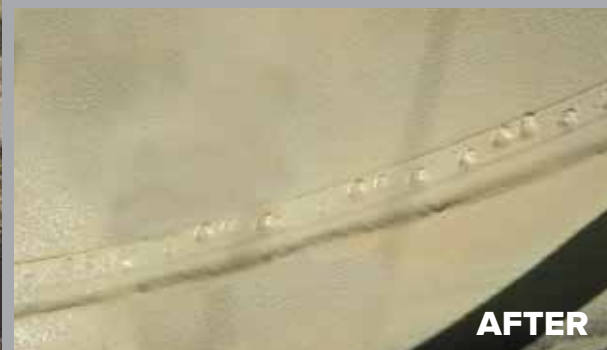
Three galvanized steel flumes originally constructed in 1984 were corroded and leaking. The replacement of the flumes and other repair methods were evaluated, but not feasible due to cost. The irrigation district chose Polyshield SS™ 100 for its corrosion resistance, its ability to bond to steel, and it was determined to be the most economical solution.

Preparation of the flumes consisted of grit-blasting a 3 to 4 mil anchor profile. One flume was so badly corroded that blasting created holes in the steel.

Polyshield SS™ 100 was used to coat the outside of the flume. This section then acted as a mold-form for the interior to be blasted and sprayed. The result was a new flume section consisting of SPI

Polyshield SS™ 100 applied at 50 mils to the exterior and 100 mils on the interior of this section.

In 2008, Tom Matheson of Matheson Painting re-inspected the flumes. Matheson stated that initially the Polyshield SS™ 100 system was to be a temporary fix. Nine years later, not having to replace the steel, it is estimated to have saved the owner over \$3,000,000.00. Matheson went on to say, "There is no sign of wear, and the product is performing like new."
