**Roza Irrigation
District Main Canal
Rehabilitation Project**

Aqualastic™

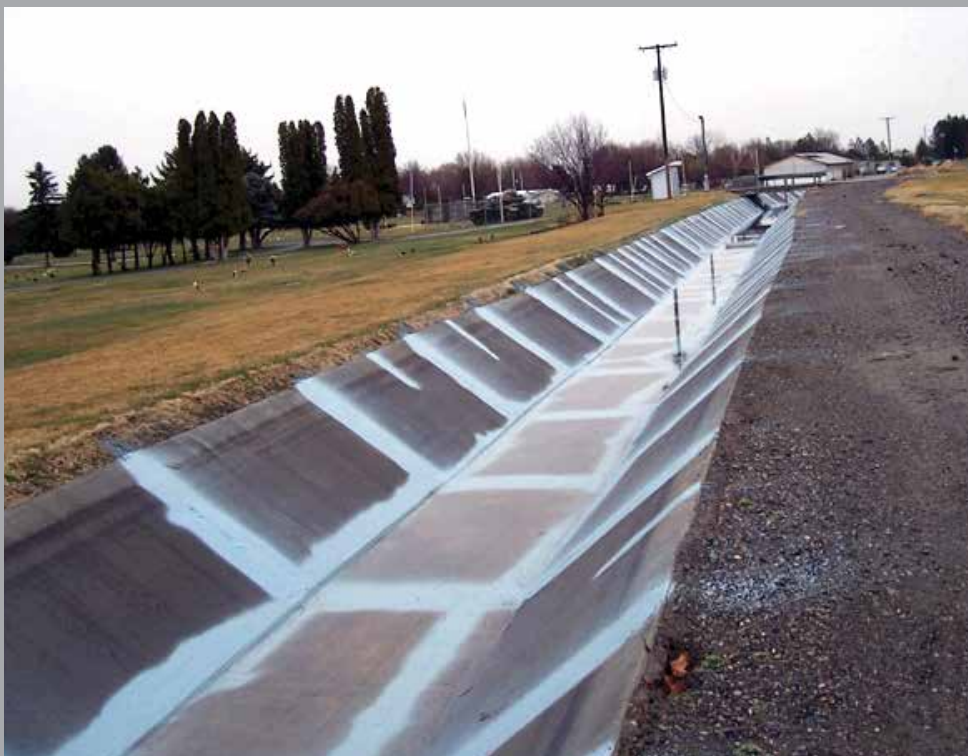
AQUALASTIC™ BRIDGES CRACKS TO ACCOMMODATE EXPANSION AND CONTRACTION FROM FREEZE-THAW CYCLES UNLIKE CONVENTIONAL CAULK/JOINT FILL PRODUCTS.

Project preparation entailed sand blasting a 3 to 4 inch wide strip on each side of the cracks in the concrete. The contractor then applied approximately 80 mils (2 mm) of Aqualastic™ to the cleaned strips, bridging the cracks to create a water-tight seal to eliminate the water loss.
