There Will Be Foam

Closed-cell SPF improves the efficiency of treater tanks at a North Dakota oil field

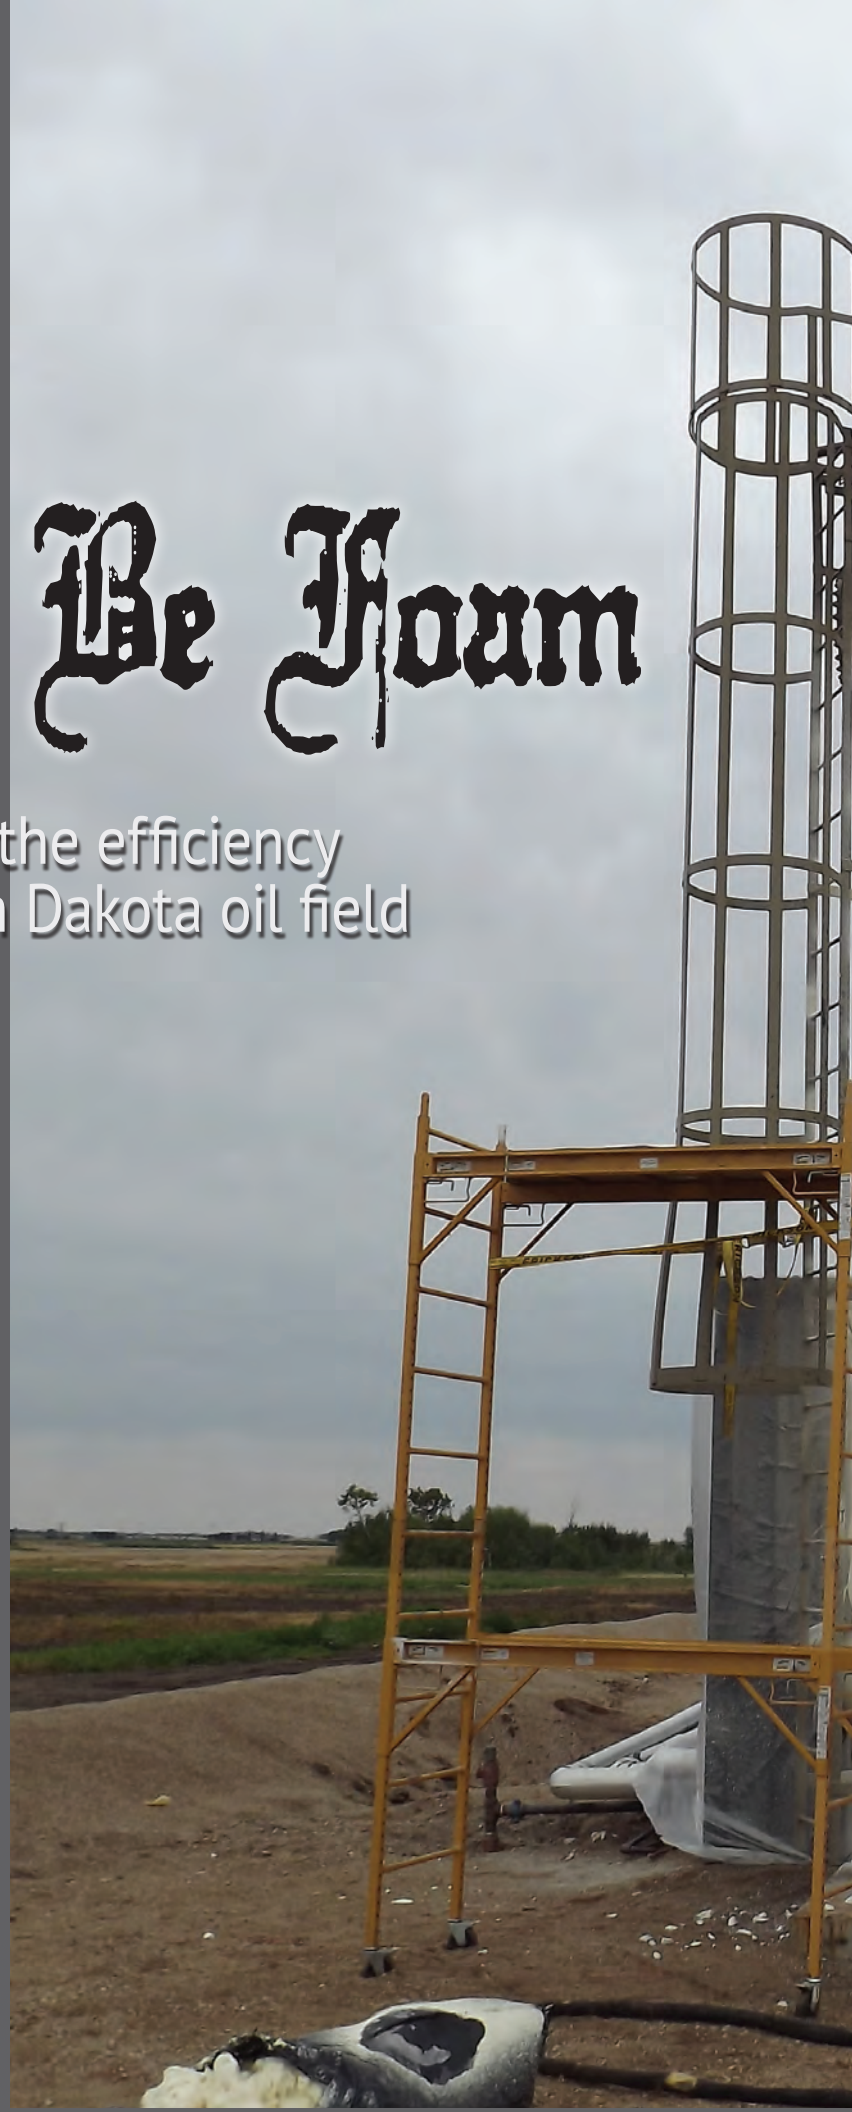
These steel oil treaters are 22-feet tall and 4-feet in diameter, with 10 by 12 valve houses attached. After the processing cycle, the treater pumps the oil through the valves located in the treater house and then into storage tanks.

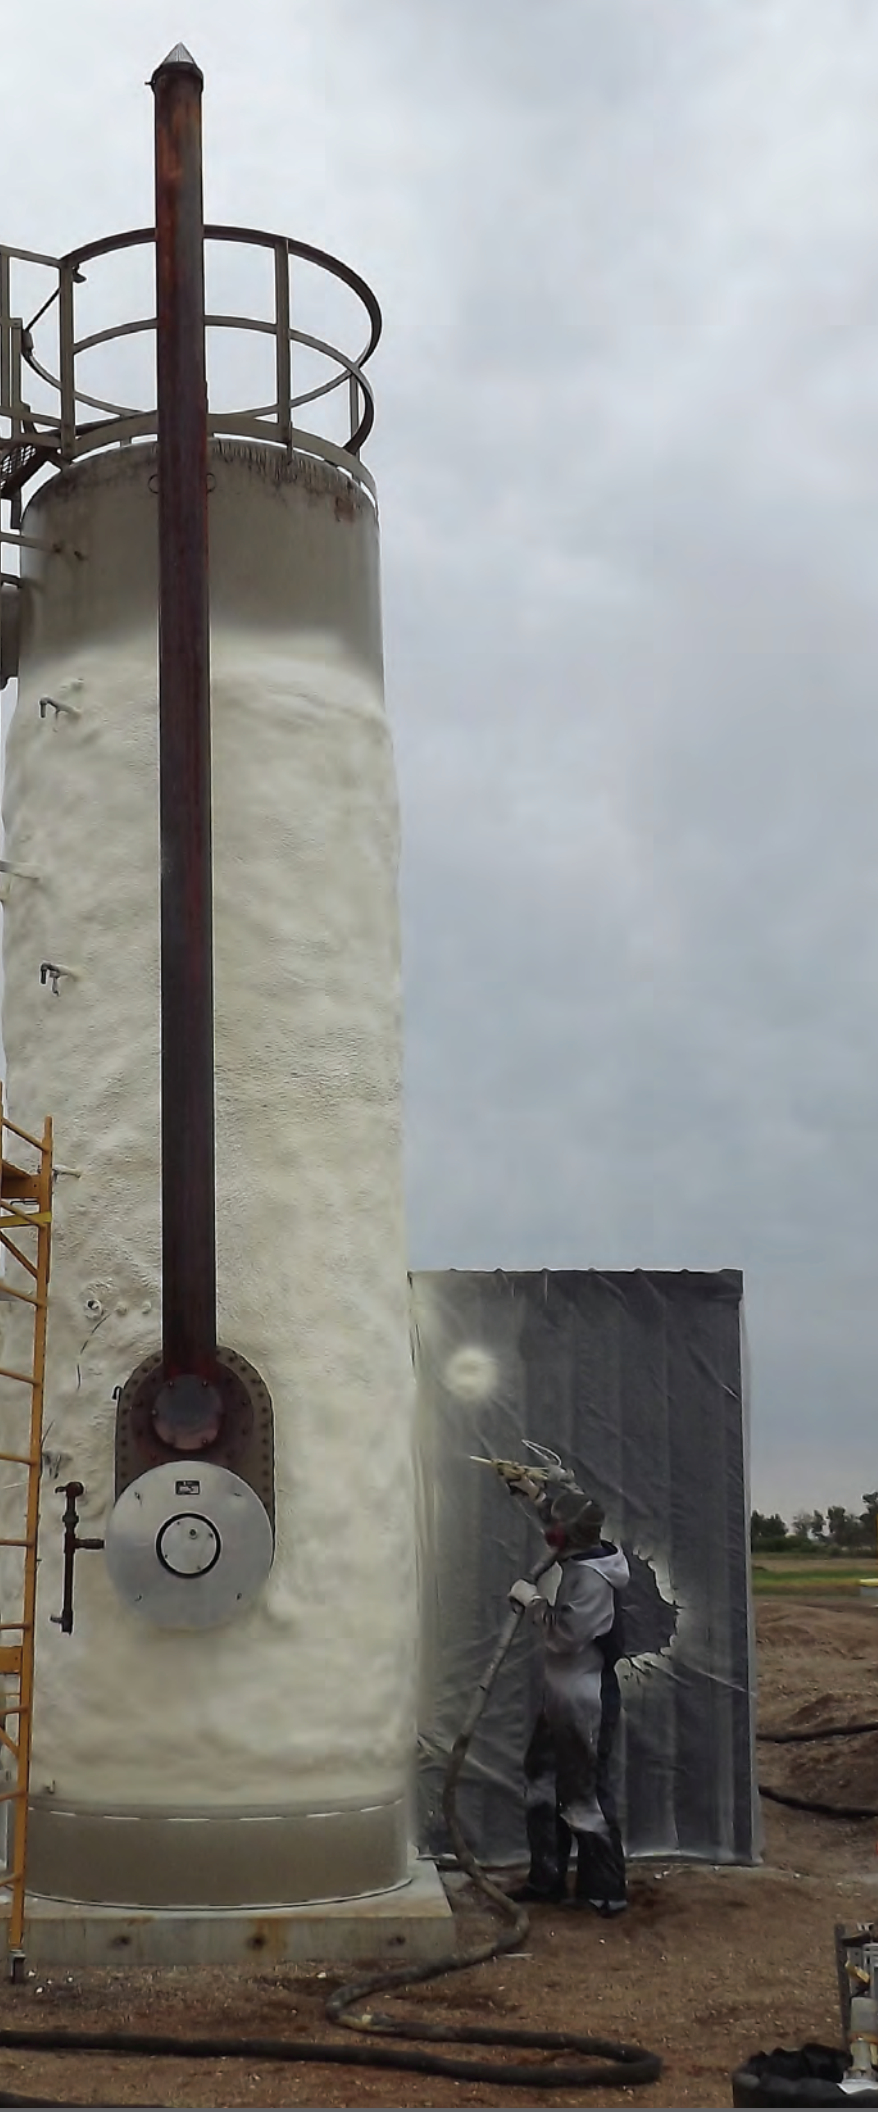
Top: the oil treater prior to the SPF application; **Left:** the interior of the valve houses were also foamed

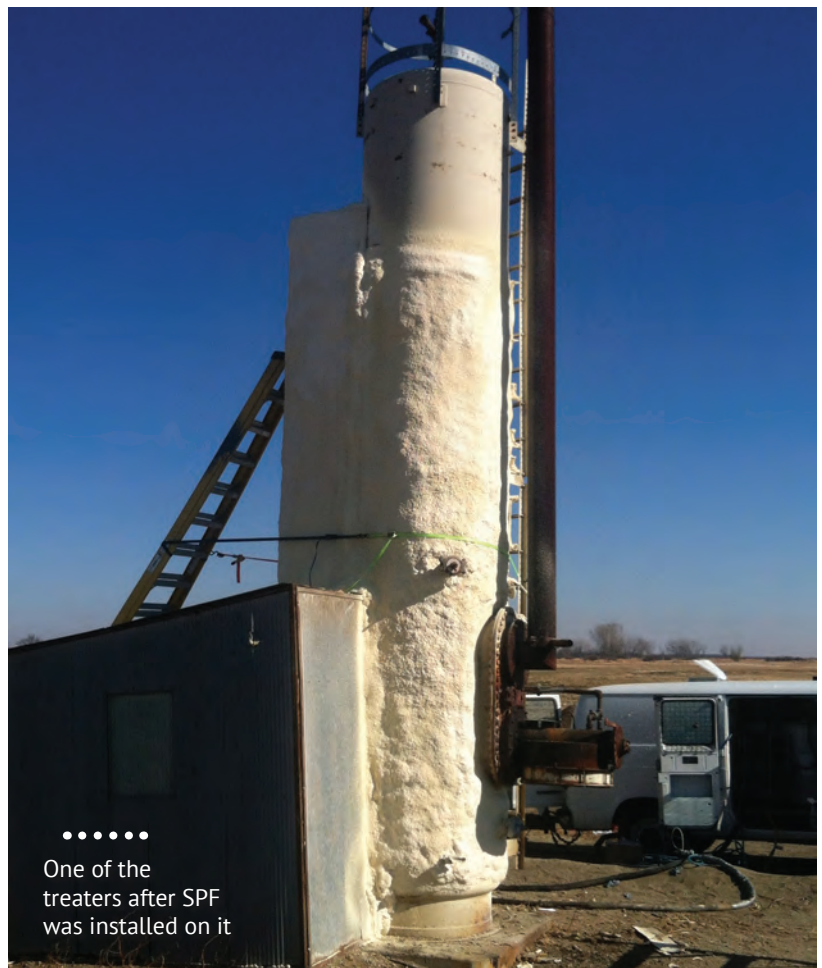
.....
One of the
treaters after SPF
was installed on it

Then, the DSS crew applied 3.5 inches of Envelo-Seal, a 2 lb. closed-cell, ignition barrier rated spray polyurethane foam made by SPI, on the treaters and valve houses. According to Zettell, the crew applied a one-inch lift of foam on the treaters, waited for it to cure, and then applied the remaining 2.5 inches later. This was done to provide extra rigidity. For the valve houses, foam was applied on the interior and exterior to maintain the pipeline valves at an appropriate temperature.

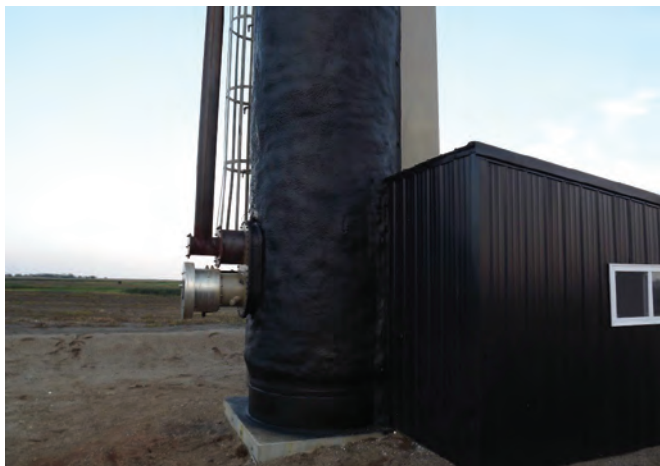
.....
Left: the treater and valve house after the SPF and polyurea applications; **Right:** SPF and polyurea were applied only on the first 15 feet of the oil treater

Zettell and his crew decided to go one step further to ensure that the insulation doesn't succumb to high winds, so they applied an 80-mil black top coat of FMJ Ultra, a spray-on polyurea bedliner coating made by SPI, on top of the foam.
