# Poly Performance

## Polyurea seals a water feature complete with lights, jets and fire

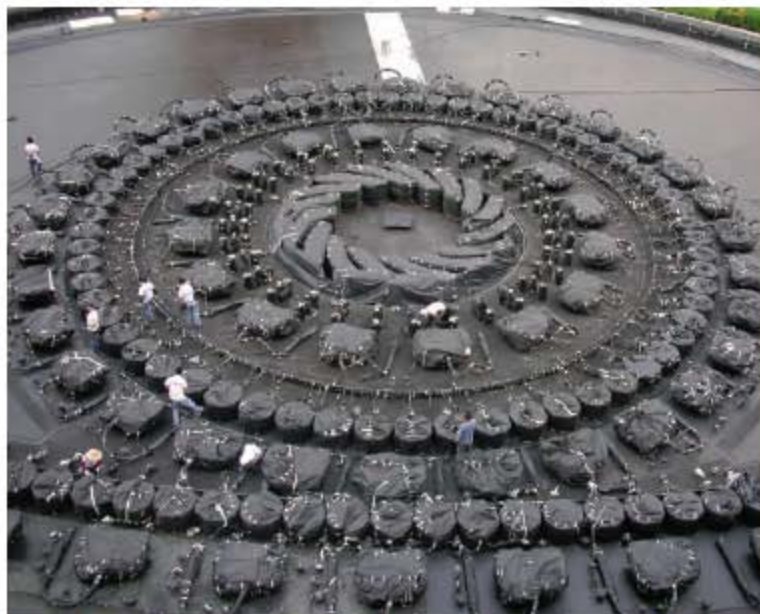
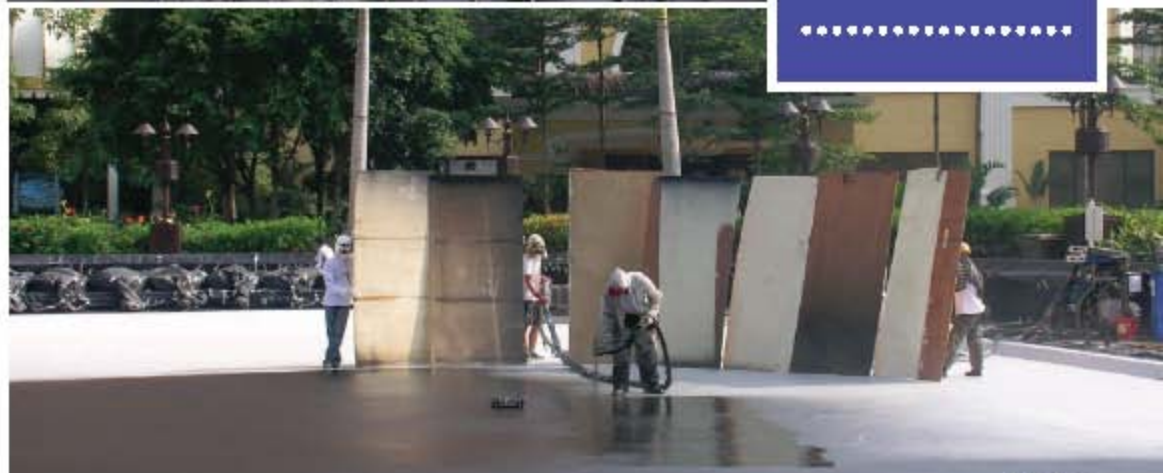
Hydrotech team sprays AMP-100-UB Pure Polyurea Black on the base of the fountain; Top: 21,000 square foot water feature is on track to be completed by the end of August

For a third time, Hydrotech sealed the new penetrations. This time, Kowalski chose to use SPI's AMP-100-UB.

"Each time we worked on the fountain we used 13 sets of polyurea," said Kowalski. "We sprayed about 1.5-2 mm of polyurea using two guns."

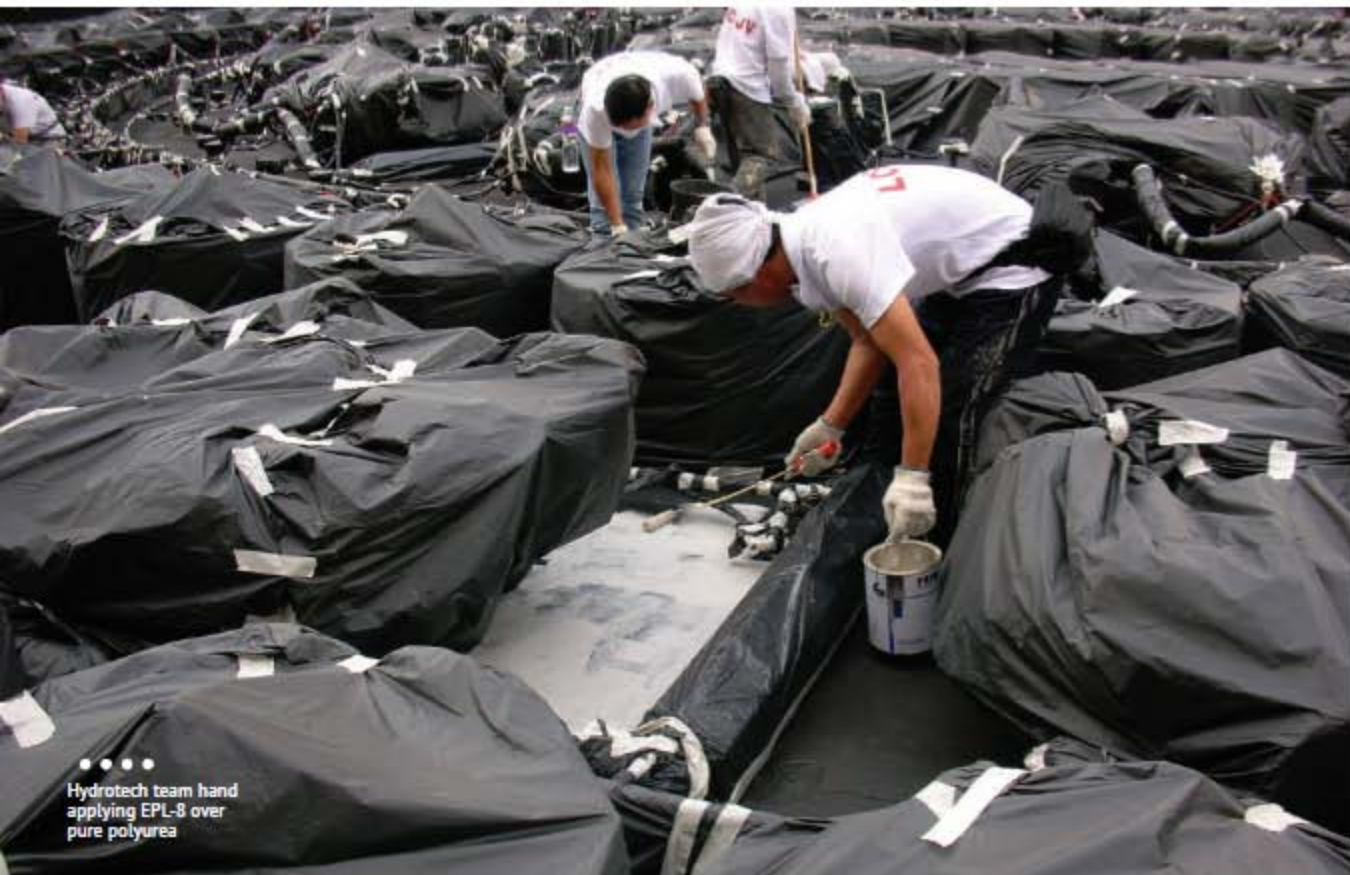
Hydrotech team hand applying EPL-8 over pure polyurea

"Waterproofing the feature was extremely important, so we sealed all penetrations with the PU sealant and then hand applied EPL-8 polyurea on top of the sealant. When all penetrations were sealed with this system, the concrete was primed with a two-component epoxy primer that was then sprayed with AMP-100."
