**PROJECT:**  
Glass Windows  
Pontiac East Truck Plant

**LOCATION:**  
Detroit, MI

**SYSTEM:**  
SPI GLASSHIELD™ 100 Polyurea applied at 24 mils on glass window inside and outside.  
SPI A102™ Polyurethane exterior topcoat (1 gallon / 100 sq. ft.)  
Interior finished with acrylic paint.

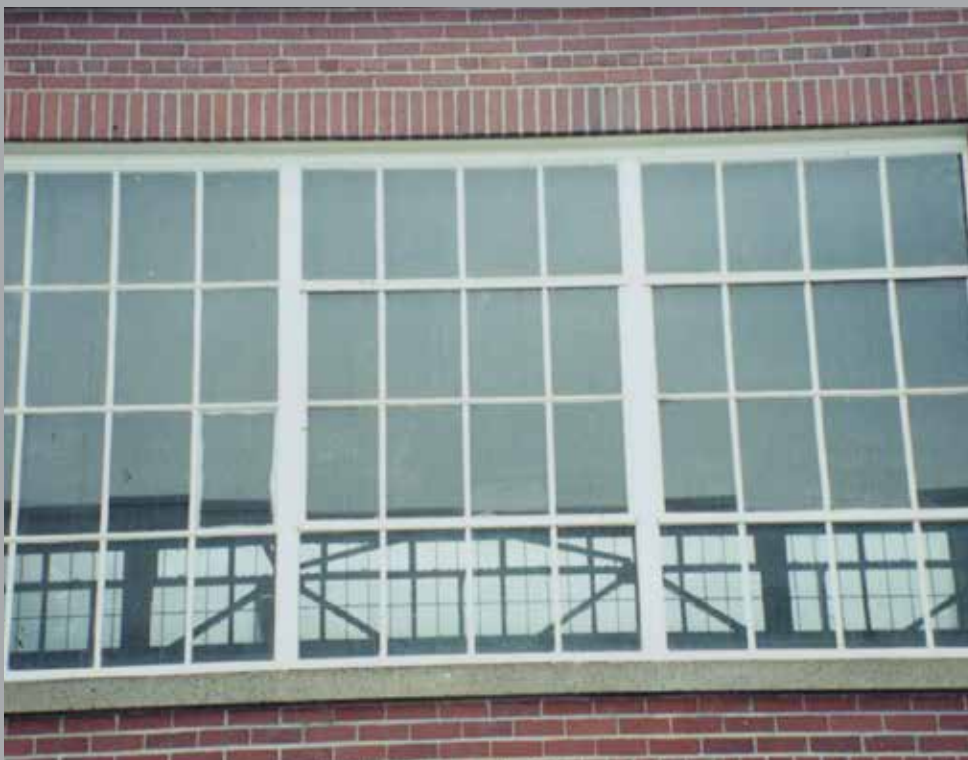
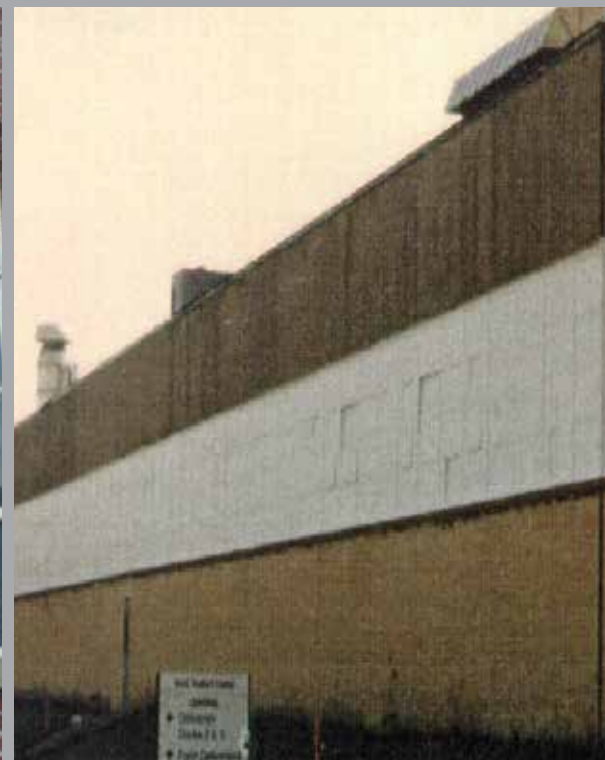
The monitor glass windows in GM's Pontiac truck plant's were aging and beginning to leak. Several of the deteriorated windows started falling out and crashing down onto the plant floors. These windows became a serious safety hazard. They needed to be stabilized and sealed, but due to the age of the windows, it had to be done without any type of surface preparation. The windows would have to remain in place and be encapsulated to prevent further damage, while eliminating any further risk of injury.

The project owner decided to use SPI's GLASSHIELD™ 100 polyurea because of it's durability and water resistant properties. The contractor applied GLASSHIELD™ 100 polyurea at 24 mils on the inside and outside of the windows. Upon request from General Motors, SPI's A102 (single component polyurethane) was custom matched to their company colors and sprayed as a topcoat on the exterior.

The GLASSHIELD™ 100 polyurea coating system stabilized and sealed the leaking, aging windows. Plant officials were satisfied with the solution, and relieved to have the safety issue resolved. The project owner awarded several new projects to the applicator in 2000 and 2002.
