PROJECT:
Apply K5™ Polyurea Coating on a Gas Pipeline, to be installed underneath a riverbed.

LOCATION:
The Balonne River in the Surat Basin, Queensland, Australia

SYSTEM:
K5™ Polyurea

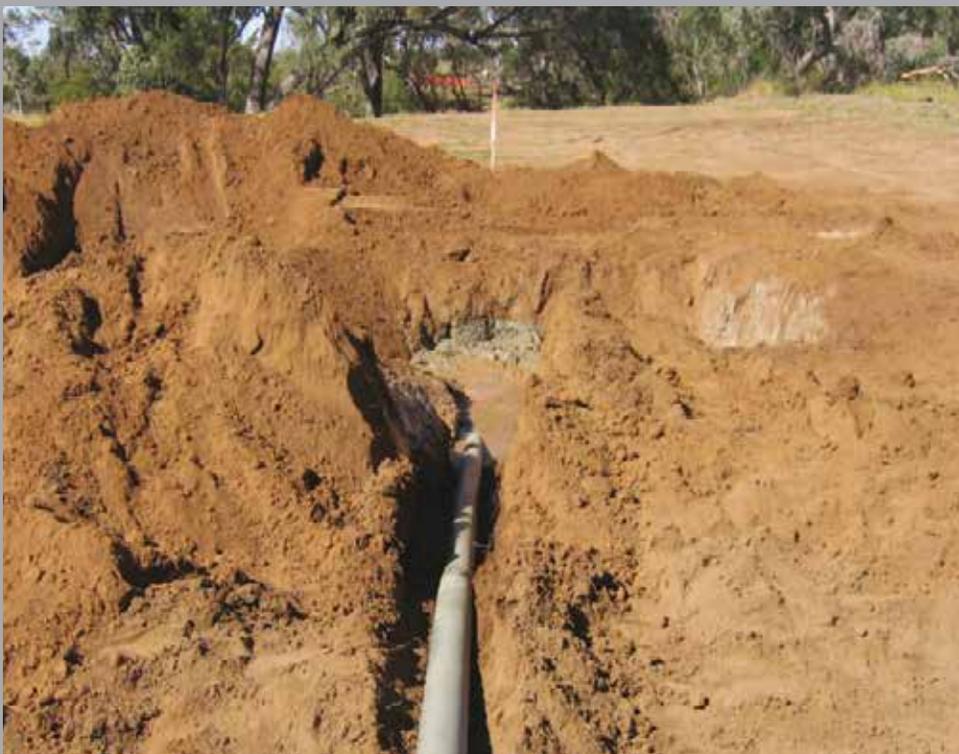
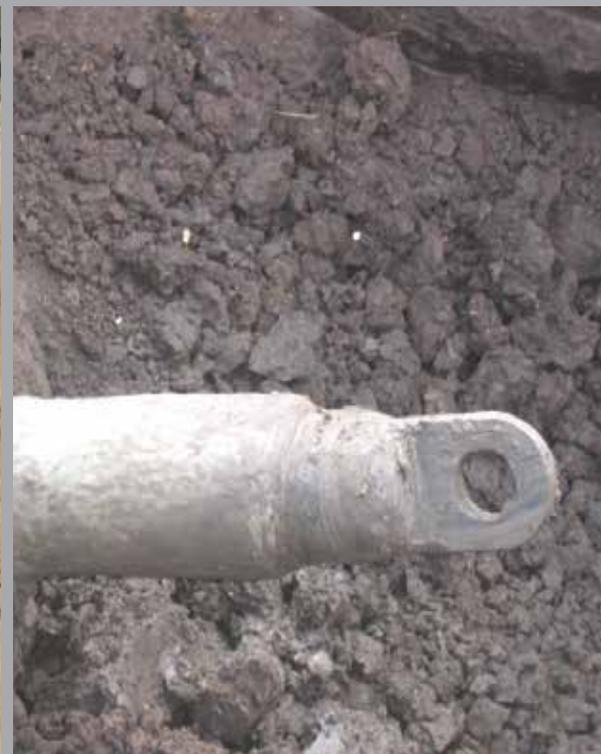
resistance and good elongation properties. In addition, the K5™ coating system creates a seamless, monolithic membrane that provides a durable barrier against corrosion and sulfate rich soil. The contractor abrasive blasted the gas pipeline to clean the surface and achieve a minimum 5 mil anchor profile for adhesion purposes. Next, 80 mils of K5™ polyurea was spray applied to the gas pipeline.

The gas pipeline was dragged through the 180m hole underneath the river. Inspections showed there were no signs of damage. The project manager said, "I would recommend K5™ for any similar coating application."
