WOODEN POWER LINE POLE FILL FEATURING Pole Fill 10-4 & L-20 Internal Splint

PROJECT:
Wood Pole Restoration

FILLING SYSTEM:
Pole Fill 10-4
and L-20 Internal Splint

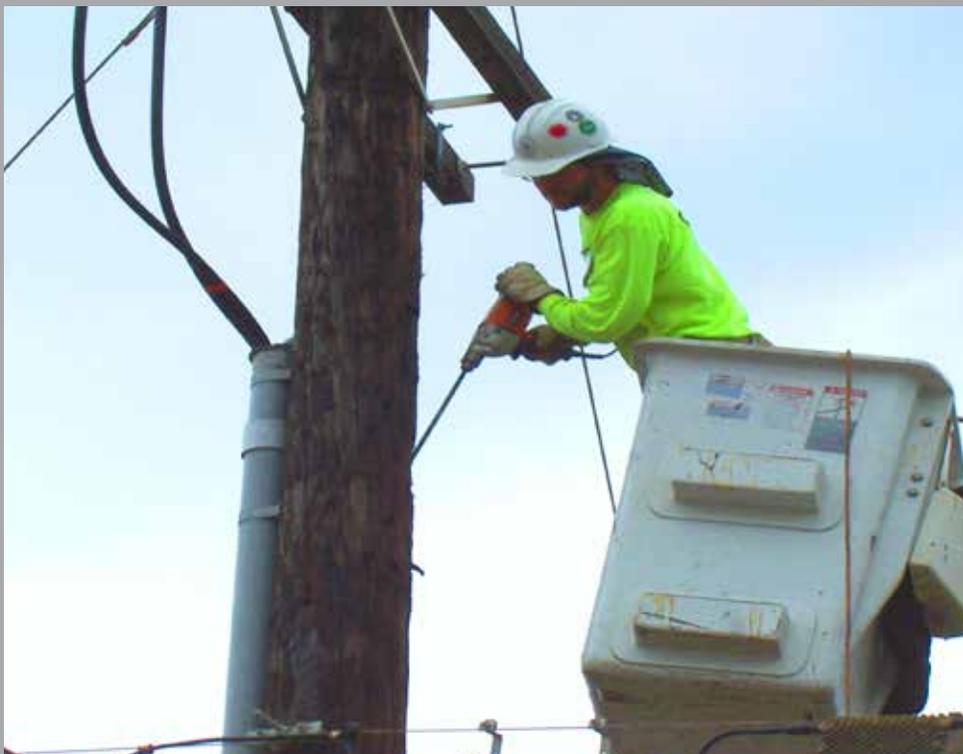
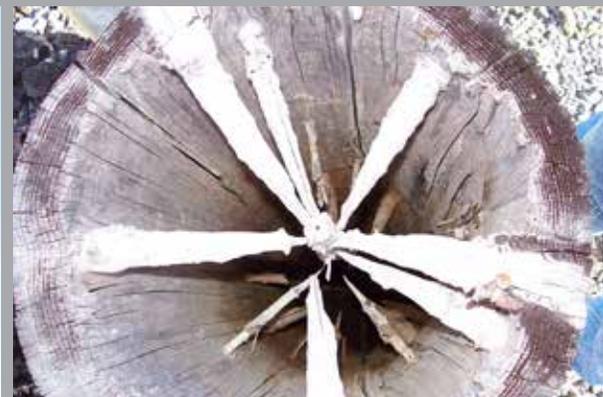
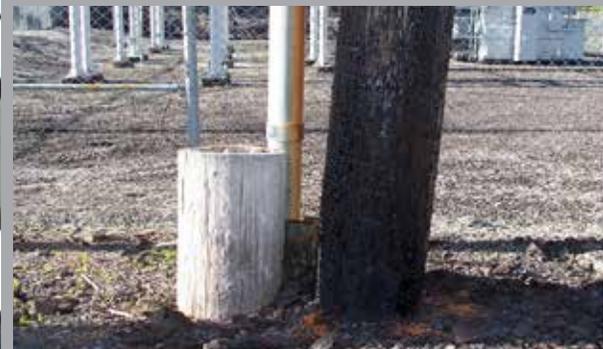
This project consists of the restoration of wooden power line poles, that are infested with termites. The termites are eating away some or most of the inside core of the wooden poles. In several instances, the damage is so severe there is less than 1 inch of the wooden shell remaining, weakening the pole and causing extensive repair costs.

SPI specifically formulated a urethane hybrid solution to inject inside the damaged power line poles. The custom formulated products Pole Fill 10-4 and L-20 Internal Splint are used to fill the cavities. The size of the pole, and how much of the inner core is missing, determines which of the specific formulations to use, and the number of gallons required for stabilization. Plugs are cut into each pole so the application equipment can fit inside. The excess substances and insects are vacuumed out. Depending on how strong the client wants the pole, between 25 and 100 gallons of Pole

Fill 10-4 and L-20 Internal Splint are pumped inside. The plugs are then pushed back into place to give it a good seal.

When hardened, the Pole Fill 10-4 and L-20 Internal Splint provides a strong, hard core inside the pole, that is impenetrable by termites and lasts for years. Over the past 15 years, the contractor's clients have been very satisfied with both products.
