## VETERINARY HOSPITAL FLOOR COATING

# FEATURING Polyshield HT<sup>™</sup> 101

Veterinary Hospital Surgical Room Floor

Polyshield HT™ 101 with AE-4 (Adhesion Enhancer) & Aluminum Oxide

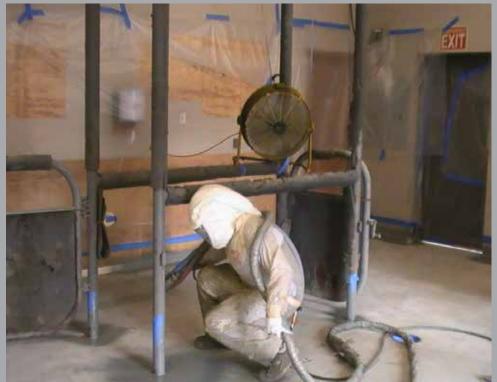
The animal hospital now has a durable and seamless protective floor coating that is resistant to most liquids and is easy to clean.

SPI's pure Polyshield HT™ 101 polyurea was chosen due to its strong abrasion and water resistant properties. After proper surface preparation, the contractor applied Polyshield HT™ 101 with AE-4 (adhesion enhancer) at a thickness of 120-140 mils. Aluminum Oxide was also broadcast into the polyurea to provide a skid-resistant surface.
