PROJECT:
HVAC Air Handling Systems

LOCATION:
Thousand Oaks, CA

SYSTEM:
POLYSHIELD HT™ Polyurea
light grey, high pigmented, UV
resistant with AE-4
(adhesion enhancer)

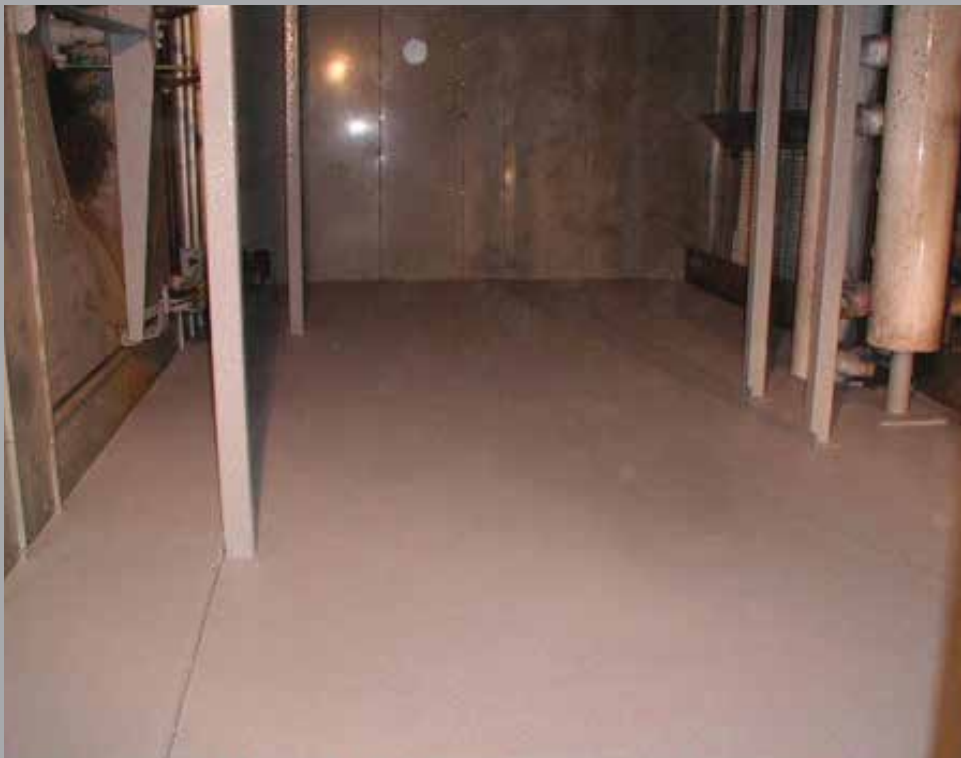
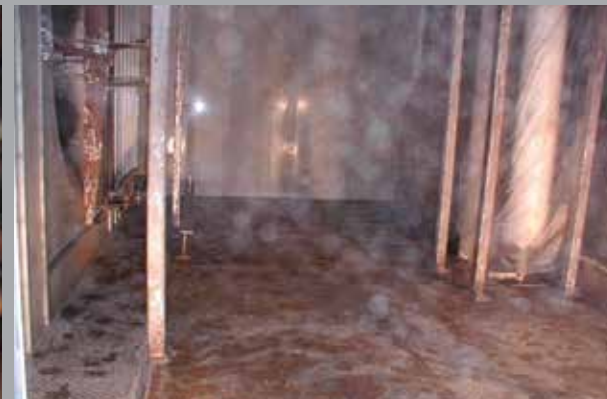
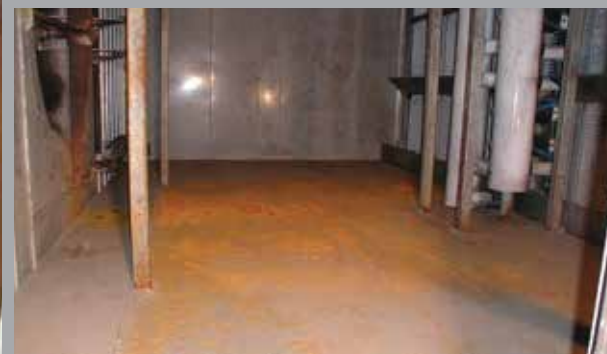
The HVAC air handling systems at a major pharmaceutical laboratory were severely corroded and began to leak. The air handling units had previously been coated with epoxies and needed recoating, due to numerous failures.

The project owner decided to use SPI's Polyshield HT™ polyurea because of the product's water resistance and high elongation properties. Before the polyurea coating could be applied, the failed epoxy coating had to be removed, along with a great deal of rust and corrosion. Grinders were used to remove the epoxy coating and corrosion, and to provide an anchor profile for proper adhesion to the substrate. Polyshield HT™ with AE-4 (adhesion enhancer) was then spray applied at a

thickness of 60-80 mils. The product's rapid curing properties allowed the air handling units to be quickly returned to service.
