FISH HATCHERY FEATURING Polyshield HT

Fish Hatchery Raceways

Juneau & Snettisham, AK

POLYSHIELD HT™ with AE-4 (adhesion enhancer)

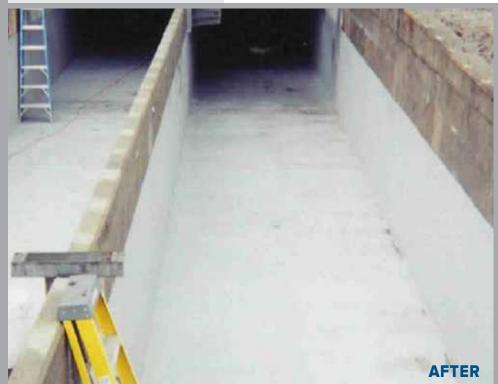
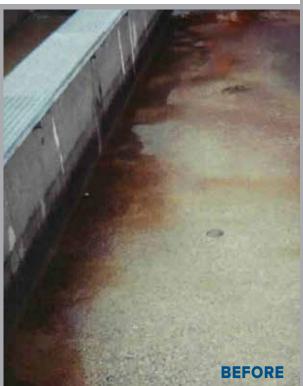
Bound for the Pacific Ocean, more than 126 million salmon pour out of the Douglas Island fish hatchery every year. In 1999, fish started dying of whirling disease, an illness that deforms the skeleton causing fish to swim in a corkscrew pattern. Fish at the hatchery live in chutes, and unfortunately for Douglas Island, the microscopic worm that causes whirling disease is small enough to wiggle through tiny cracks in the concrete walls. That put the entire crop at risk. Douglas Island needed a way to quarantine the infected fish.

Replacing the walls completely would cost too much time and money. Thanks to Specialty Products, that wasn't necessary. The hatchery sprayed the walls with Polyshield HT™, which is impermeable to water, keeping the deadly worms from wriggling between chutes.

Prior to application of Polyshield HT™, the concrete was prepped with a high-pressure wash using a biodegradable soap, dried, and then vacuumed. In order to avoid the additional step and expense of applying a primer, AE-4 (adhesion enhancer) was added to Polyshield HT™ which was applied directly to the concrete at 100-500 mils. The product's rapid curing properties allowed Douglas Island to quickly return to the business of raising fish.

The owner was extremely pleased with the fast cure time, and the hatchery was able to put the raceways back to service immediately. The original contract was awarded for 8 raceways. Due to the excellent performance of Polyshield $HT^{\text{\tiny IM}}$, the remaining 27 raceways were awarded to the contractor the following year.
