Aviation Fuel Hydrant Pits

Anchorage, AK

POLYSHIELD SS™ 100 Polyurea

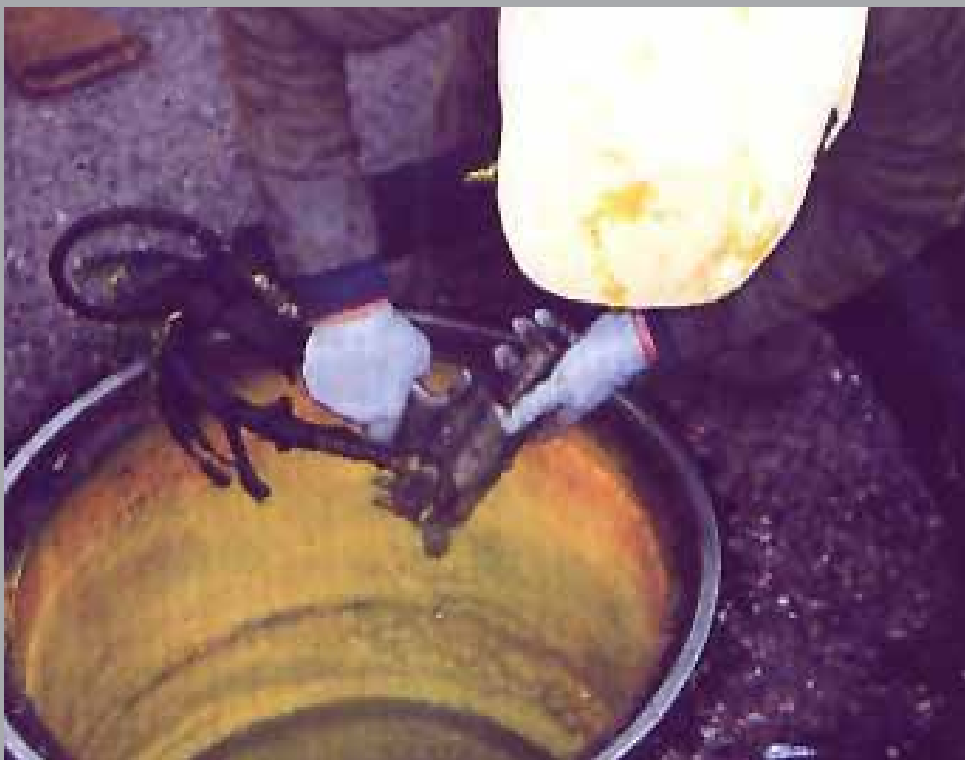
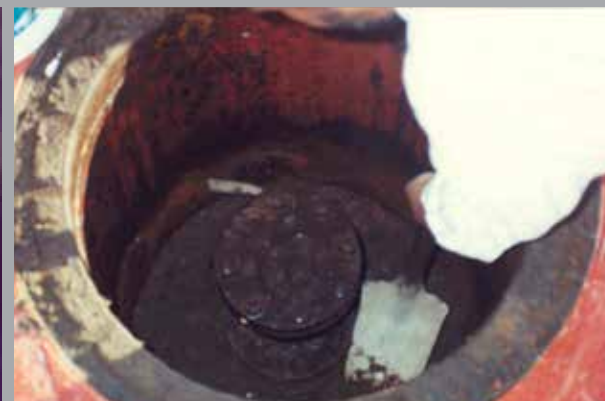
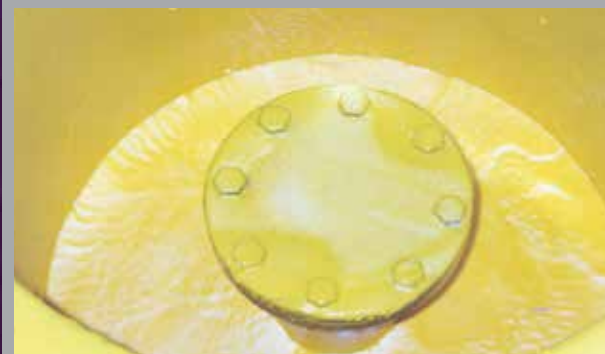
The applicator spray-applied 80 mils of a translucent yellow Polyshield SS™ 100 polyurea. The color yellow was chosen to contrast the darker substrate, making it easy to visually determine the thickness of the coating. The polyurea coating was applied over various substrates (concrete, geo-textile fabric, and directly onto the ground).

Polyshield SS™ 100 is performing exceptionally well. These pits are continually exposed to water, anti-icing agents, and jet fuel. The coating has some color change, but no signs of deterioration.
