POND RESTORATION & LEAK PREVENTION **FEATURING Polyshield SS[™] 100**

PROJECT: Volunteer Park Lily Ponds

LOCATION: Seattle, Washington

SYSTEM: Polyshield SS[™] 100 over SPI Polyprime[™] 100

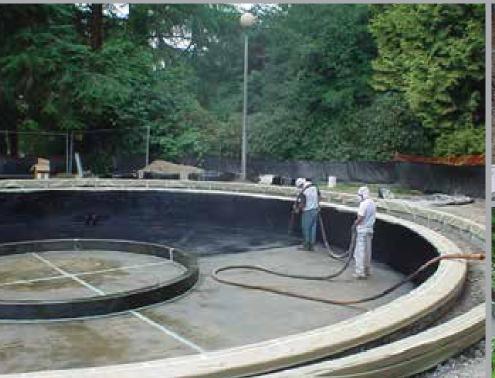
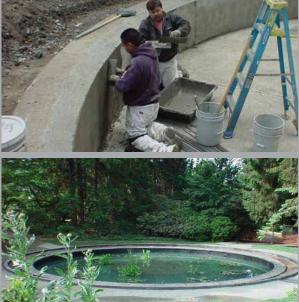
100-year old twin concrete lily ponds in the heart of Seattle's Volunteer Park fell into disrepair. Once the concrete ponds were damaged beyond repair, they were drained of water and lilies, and sat unused for over twenty years.

SPI's Polyshield SS[™] 100 was chosen because of its durability, elongation, and hydrophobic properties allowing for application to damp, cool surfaces. The old concrete surface was prepared by pressure washing and concrete patching. The concrete surface was primed with SPI's Polyprime[™] 100. Next Polyshield SS[™] 100 was applied at thickness of 125 mils.

The ponds were inspected by a Seattle Parks and Recreation official two years later. There were no leaks and the coating was still firmly adhering to the concrete.
