WATER PROOFING

FEATURING Polyshield SS™ 100

Fountain of the Flags

Fairbanks, AK

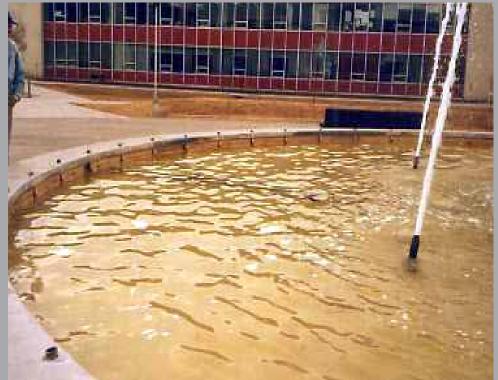
Microscopic cracks were found in the original epoxy coating of a 3,000 sq. ft. water feature, "The Fountain of the Flags" at the University of Alaska, Fairbanks. These cracks were causing leaks with a daily loss of thousands of gallons of water. The water was making its way into the plumbing corridor under the fountain, which potentially could be a serious and expensive problem if left untreated.

membrane that prevents water leakage. With high pigment added for color stability, Polyshield $SS^{\text{\tiny{M}}}$ 100 was applied at 60 mils. The polyurea protective coating created a watertight seal.

University officials were relieved to have a reliable waterproof coating in place to protect the water feature's concrete surface. In a follow up inspection (summer 1996) the coating was performing well, with no loss of water and no discoloration.
