Water Tank/Concrete Restoration

Oyster Bay, NY

AQUASEAL[™] Synergy Series
Polyurea Coating - 80 mils

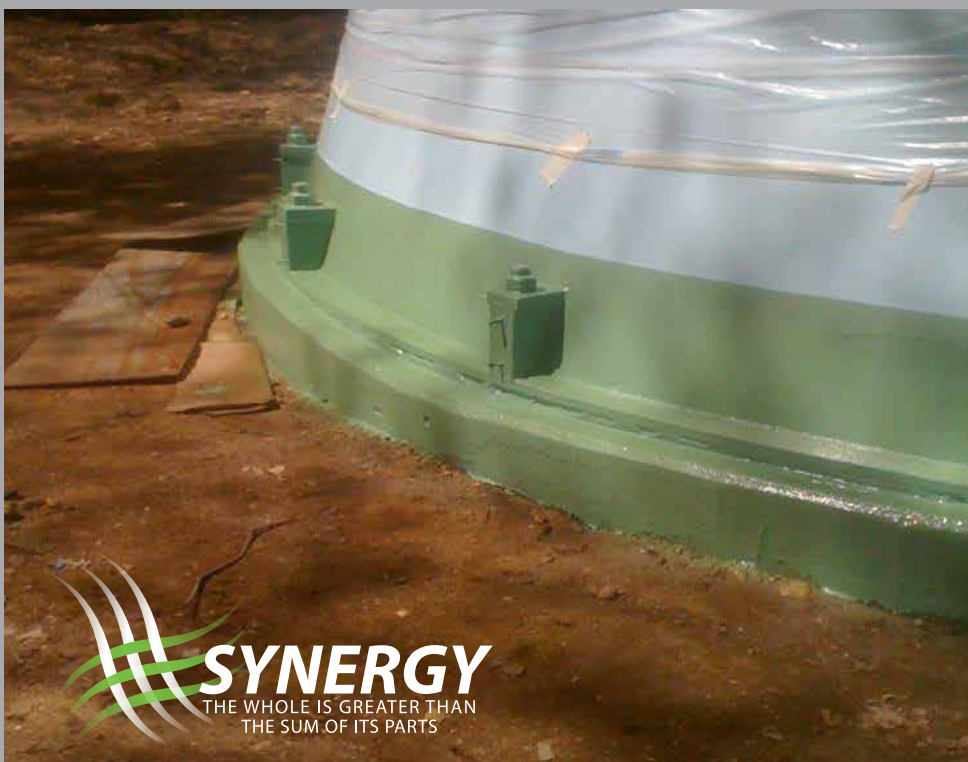
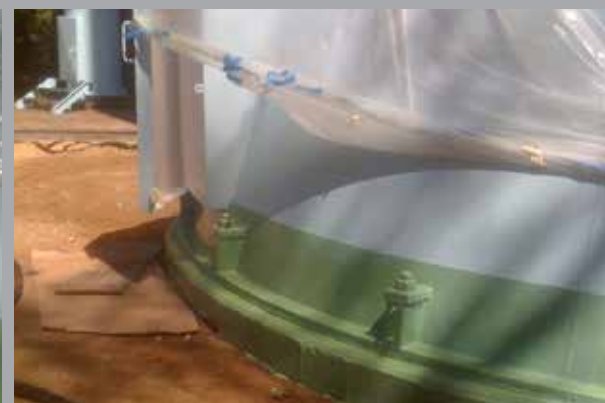
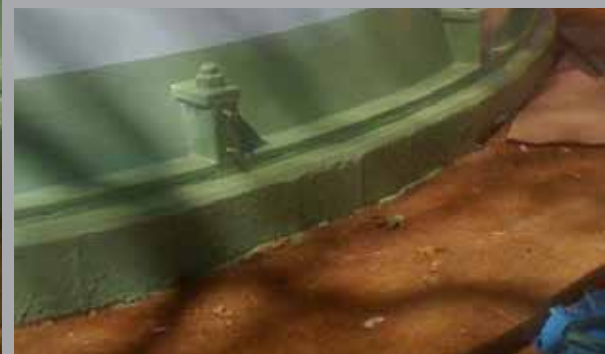
The Water Authority of Oyster Bay, NY wanted to eliminate the moisture zone between the concrete and steel base of a water tower. Condensation would occur, due to the humid climate, and run down the side of the tank, gathering at the seam between the concrete and steel. This moisture problem was causing the concrete to spall and the steel to deteriorate from rust.

Nick Pjatikin, of Delphi Engineering, installed Aquaseal[™] Synergy Series polyurea using SPI's LPG[™] (Low Pressure Gear) mobile equipment. The polyurea seamless liner bridged the steel tank, concrete foundation, and anchor bolts. This provided a seamless, waterproof, protective liner that fully adhered to all of the substrates.

Prior to the application of polyurea, the Delphi applicators prepared the multiple surfaces to ensure proper adhesion. The concrete was media blasted to remove all

debris particles and damaged concrete. The freshly painted steel was scuffed to take off the shine and provide an anchor profile to promote better adhesion.

The applicator spray-applied 80 mils of Aquaseal[™] polyurea. Finally, a two part urethane paint was added for U.V. color stability and aesthetic purposes to color match the rest of the tank.
