PROJECT:
Cooling Tower Protection

LOCATION:
Goddard Space Flight Center
Greenbelt, Maryland

COATING SYSTEM:
PTU™ Chemical Resistant
Polyurea Coating - 120 mils

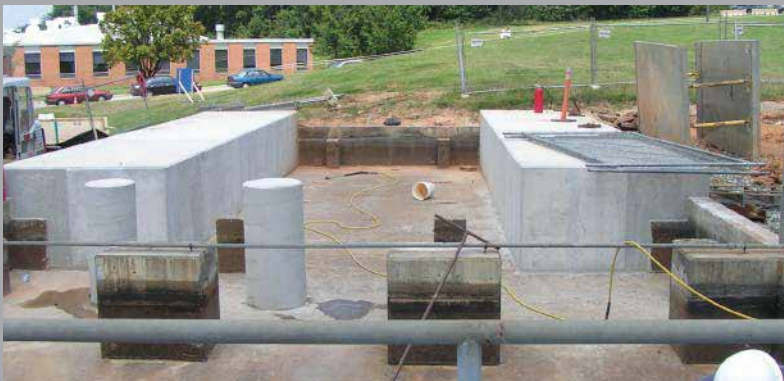
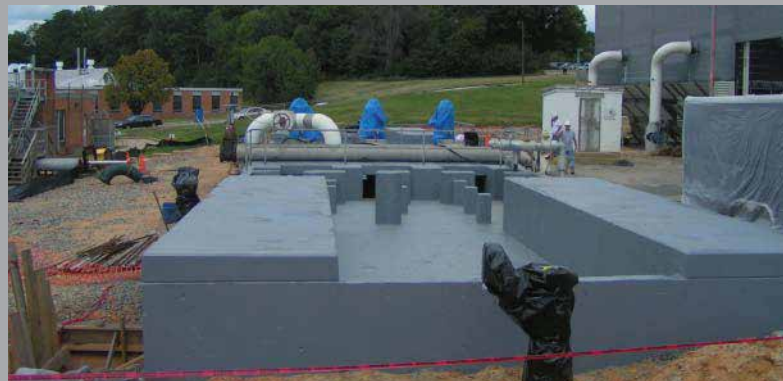
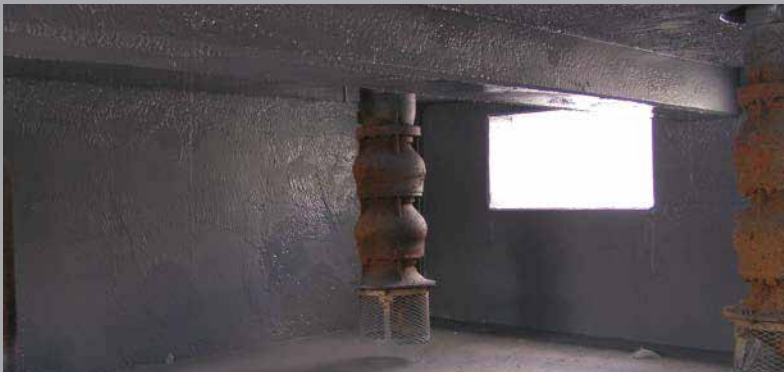
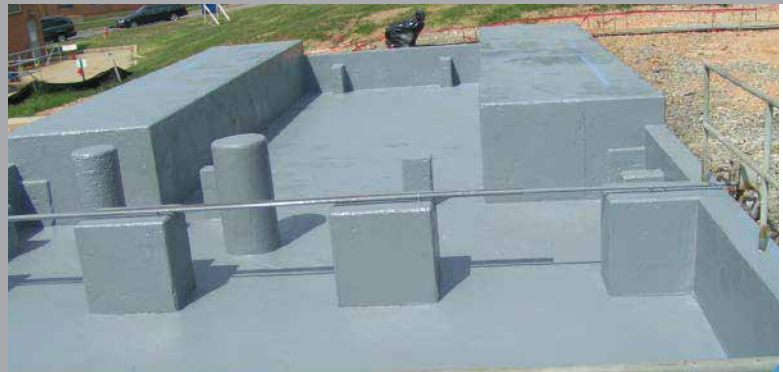
NASA's facility management team was experiencing issues with a recently constructed cooling tower. The cooling tower was essential for maintaining proper HVAC conditions in important operational buildings. Chemical solutions used to treat the water in the cooling tower were damaging the concrete and accelerating deterioration. Facility management was looking for a protective coating solution to stop the concrete erosion and avoid the need for expensive repairs. Any potential coating would have to be resistant to the water treatment chemicals, and also be able to flex with the concrete movement from annual thermal cycles.

The applicator started the surface preparation process by removing any surface latents, making sure they had a clean & dry substrate. Then a thin-film coating of Deep Seal® moisture barrier and Polyprime™ 100 primer were roll-applied to seal the pores in the concrete surface.

After the surface was properly prepared, the applicator sprayed 120 mils of SPI's PTU™ chemical resistant polyurea over the concrete cooling tower's interior and exterior surfaces.

The Goddard Space Flight Center facility management team conducted several inspections during and after the project was completed. The coating has maintained great adhesion to the surface. Facility managers were completely satisfied with the results. They have a protective coating in place that will drastically increase the cooling tower's service life. NASA's investment in SPI's polyurea, protective coating provided a reliable solution at a fraction of the cost compared to replacing the cooling tower.
